HydroQuest

Recent Mining and Grading Activity on the 850 Route 28 Property Leading to Degradation of Hydrologic & Biologic Resources Inclusive of Pickerel Pond

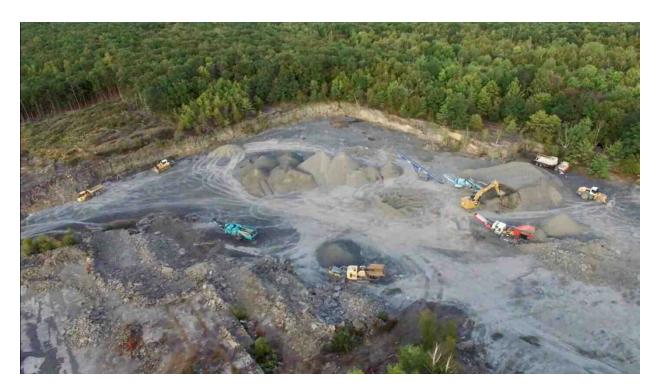
Figure 1. Expansive mining operation on the 850 Route 28 property on September 30, 2021. Recent mining activity extended approximately another 500 feet southwest of the quarry working area depicted above.

- Potential quarry expansion into the bedrock promontory situated some 350 feet northwest of the 0.4-acre rock mound formerly present in the 1970s quarry footprint (Figure 1).

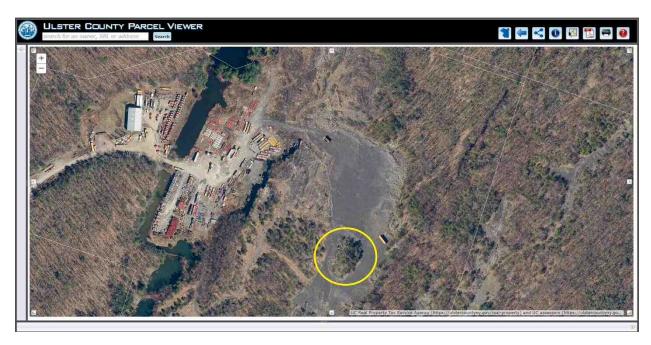
The October 4, 2021 NYSDEC letter potentially provided for the processing of approximately 3,500 cubic yards of loose shot rock, assuming that required Town approvals had been satisfied. The approximately 0.4-acre mound some 28 feet high that is depicted on the attached GIS map and Figure 2 below has now been removed. Based on LiDAR-derived elevational data, its volume was on the order of 14,000 yds³, some <u>four times</u> the anticipated rock processing material.

Figure 2. Spring 2021 imagery depicting tree-covered quarry mound (yellow circle) prior to excavation. For size comparison, note that its size is much smaller than the partial quarry area depicted above on Figure 1. Note also, the former free-flowing stream outflow pathway of Pickerel Pond toward the upper left of the image. Figure 7 contrasts the Pickerel Pond outlet before and after recent dam construction.

- Removal of a 0.4-acre, 28-foot high, rock mound formerly within the 1970s quarry area with a volume on the order of 14,000 yds³, some <u>four times</u> the anticipated rock processing material volume (GIS map and Figure 2); and

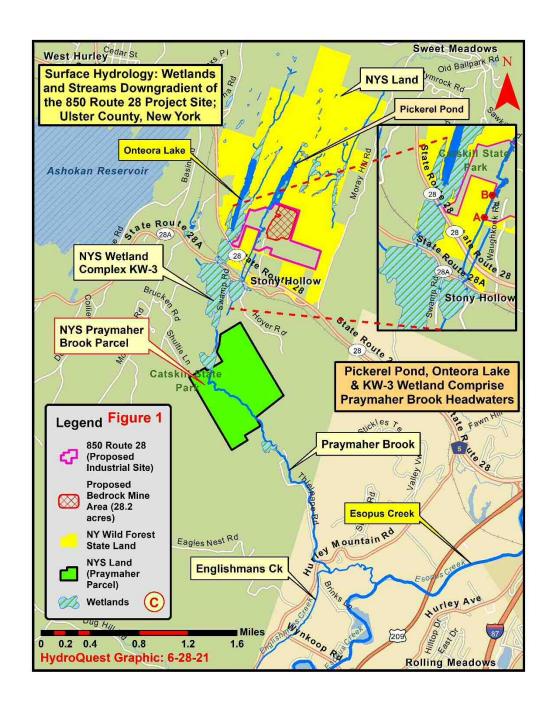
Figure 3. The flow path of Praymaher Brook extends southward from State-owned Onteora Lake and Pickerel Pond, through the State-owned Praymaher Brook Parcel, and downstream to its junction with Englishmans Creek.

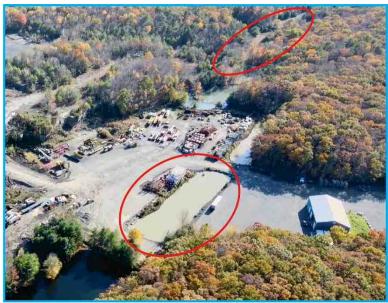
Fine quartz particulates stemming from quarry mining operations become entrained in surface water runoff and from direct grading into site ponds. Their small particle size and slow settling rates result in their staying in suspension for long periods of time (e.g., weeks or longer). The red ellipses on Figure 4 show highly turbid water in Pond (bottom turbid pond) downgradient (upper red ellipse) along the Praymaher Brook stream course. NYSDEC's Cease-and-Desist directive letter provides excellent photographs of turbid, sediment-laden, water downstream ponds resulting from site mining and grading activities. Review of these photographs is instructive from

Figure 4. Sediment laden Pond B exhibits the uncontrolled release of fine particulates into Praymaher Brook.

Based on observation that recent mining and grading activities on the 850 Route 28 site have degraded the water quality in numerous ponds and almost certainly Praymaher Brook, no additional mining, rock processing, or grading activity should be permitted on the site property;

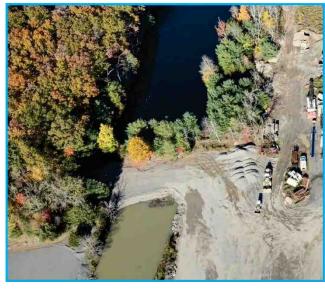
Recent unpermitted 850 Route 28 site activities included construction of a wide dam (the "850 Dam"), approximately four feet in height, across the outlet of Pickerel Pond (Figures 6, 7 and 8). HydroQuest does not know if a culvert was installed beneath the dam material. If present, it would not facilitate the free passage of wildlife (e.g., beavers, muskrats).

Figure 6. The 850 Dam now abuts Pickerel Pond and blocks its outflow.

- Construction of the wide 850 Dam situated at the southwestern end of 16.3-acre Pickerel Pond where headwater drainage of Praymaher Brook formerly flowed freely and a nearly constant pond elevation was maintained. The dam dimensions are estimated as four feet high with a width on the order of 70 feet (Figures 6, 7, and 8);

construction of a dam at the pond outlet may irreparably alter and harm the existing ecosystem. The yellow 103-acre Pickerel Pond Watershed tributary to this dam (Figure 5) is now beheaded from its downstream reaches of Praymaher Brook. The 850 Dam should be removed immediately before a significant rise in pond level occurs. On November 21, 2021 HydroQuest established a datum from which to monitor increases in pond level until the dam is removed and natural stream throughflow has been restored.

Completely remove the 850 Dam placed at the outlet of Pickerel Pond and restore the natural flow route of this headwater reach of Praymaher Brook. This restoration work should be guided and supervised <u>continuously</u> by both a NYSDEC hydrologist and a NYSDEC biologist. This work should be completed prior to spring high runoff conditions and species breeding periods;

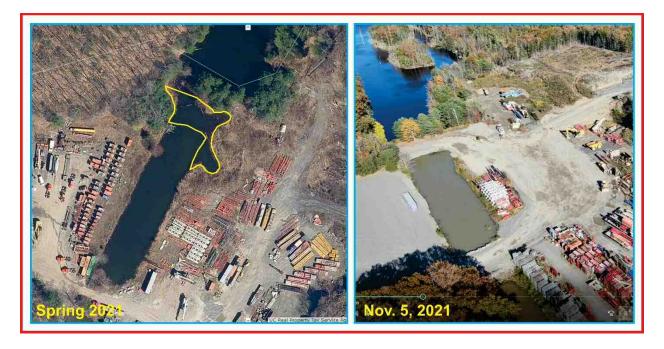
Figure 7. Unpermitted dam construction and blockage of Pickerel Pond outflow within the headwaters of Praymaher Brook. The yellow polygon approximates a 0.3-acre fill zone. Drone imagery documents fill placement sometime between 9-30-21 and 11-05-21.

- Placement of a large quantity of fill near the southeastern corner of Pickerel Pond (Figure 7) that has the potential of degrading Pickerel Pond water quality during runoff events;

- Partial filling of the man-made pond (Pond B), situated immediately southwest of Pickerel Pond, primarily within its northeastern end (approximately 0.3-acres; Figure 7);

- Placement of fill alongside and into the western side of man-made Pond B immediately southwest of Pickerel Pond for a distance of approximately 400 feet (Figure 7);

- Placement of fill alongside and into the southeastern corner of man-made Pond B (Figure 7);
- Significant water quality degradation from entrainment of fine particulates and oil into a series of man-made ponds downgradient of Pickerel Pond, with discharge into Praymaher Brook (11-05-21 NYSDEC Cease-and-Desist letter, Figures 4, 6, and 7);

Remove the recent fill placed near the southeastern corner of Pickerel Pond or install a berm between the fill and Pickerel Pond to eliminate all risk of sediment transport/runoff into Pickerel Pond:

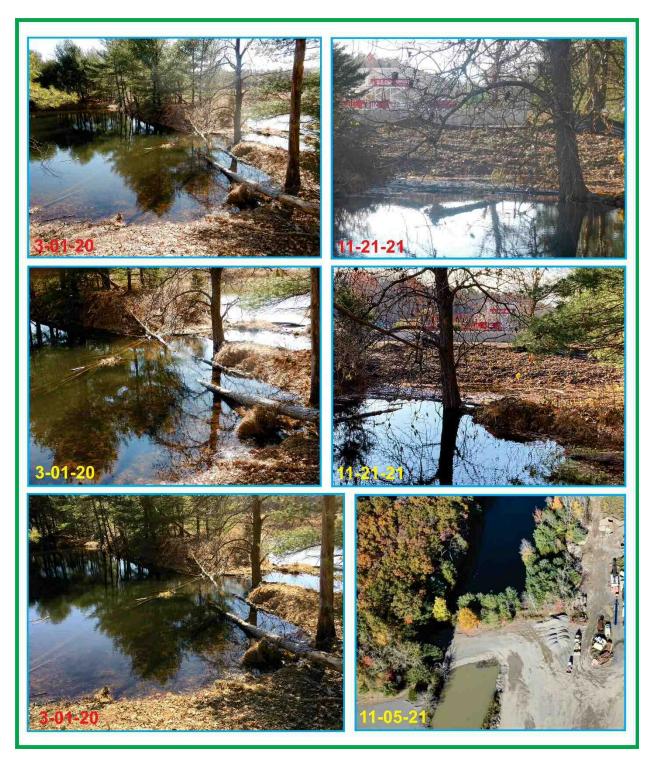
Figure 8. The left side photographs document the open conveyance of surface water through and out of Pickerel Pond along this headwater reach of Praymaher Brook in March 2020. The November 2021 photographs show the constructed 850 Dam that disrupts natural pond outflow and brook flow.
