# HydroQuest

May 5, 2020

## **Surface Hydrology, Hydrogeology, Bluestone Quarries, and Glacial Geology Proximal to Pickerel Pond and the Proposed 850 Route 28 Manufacturing Facility**

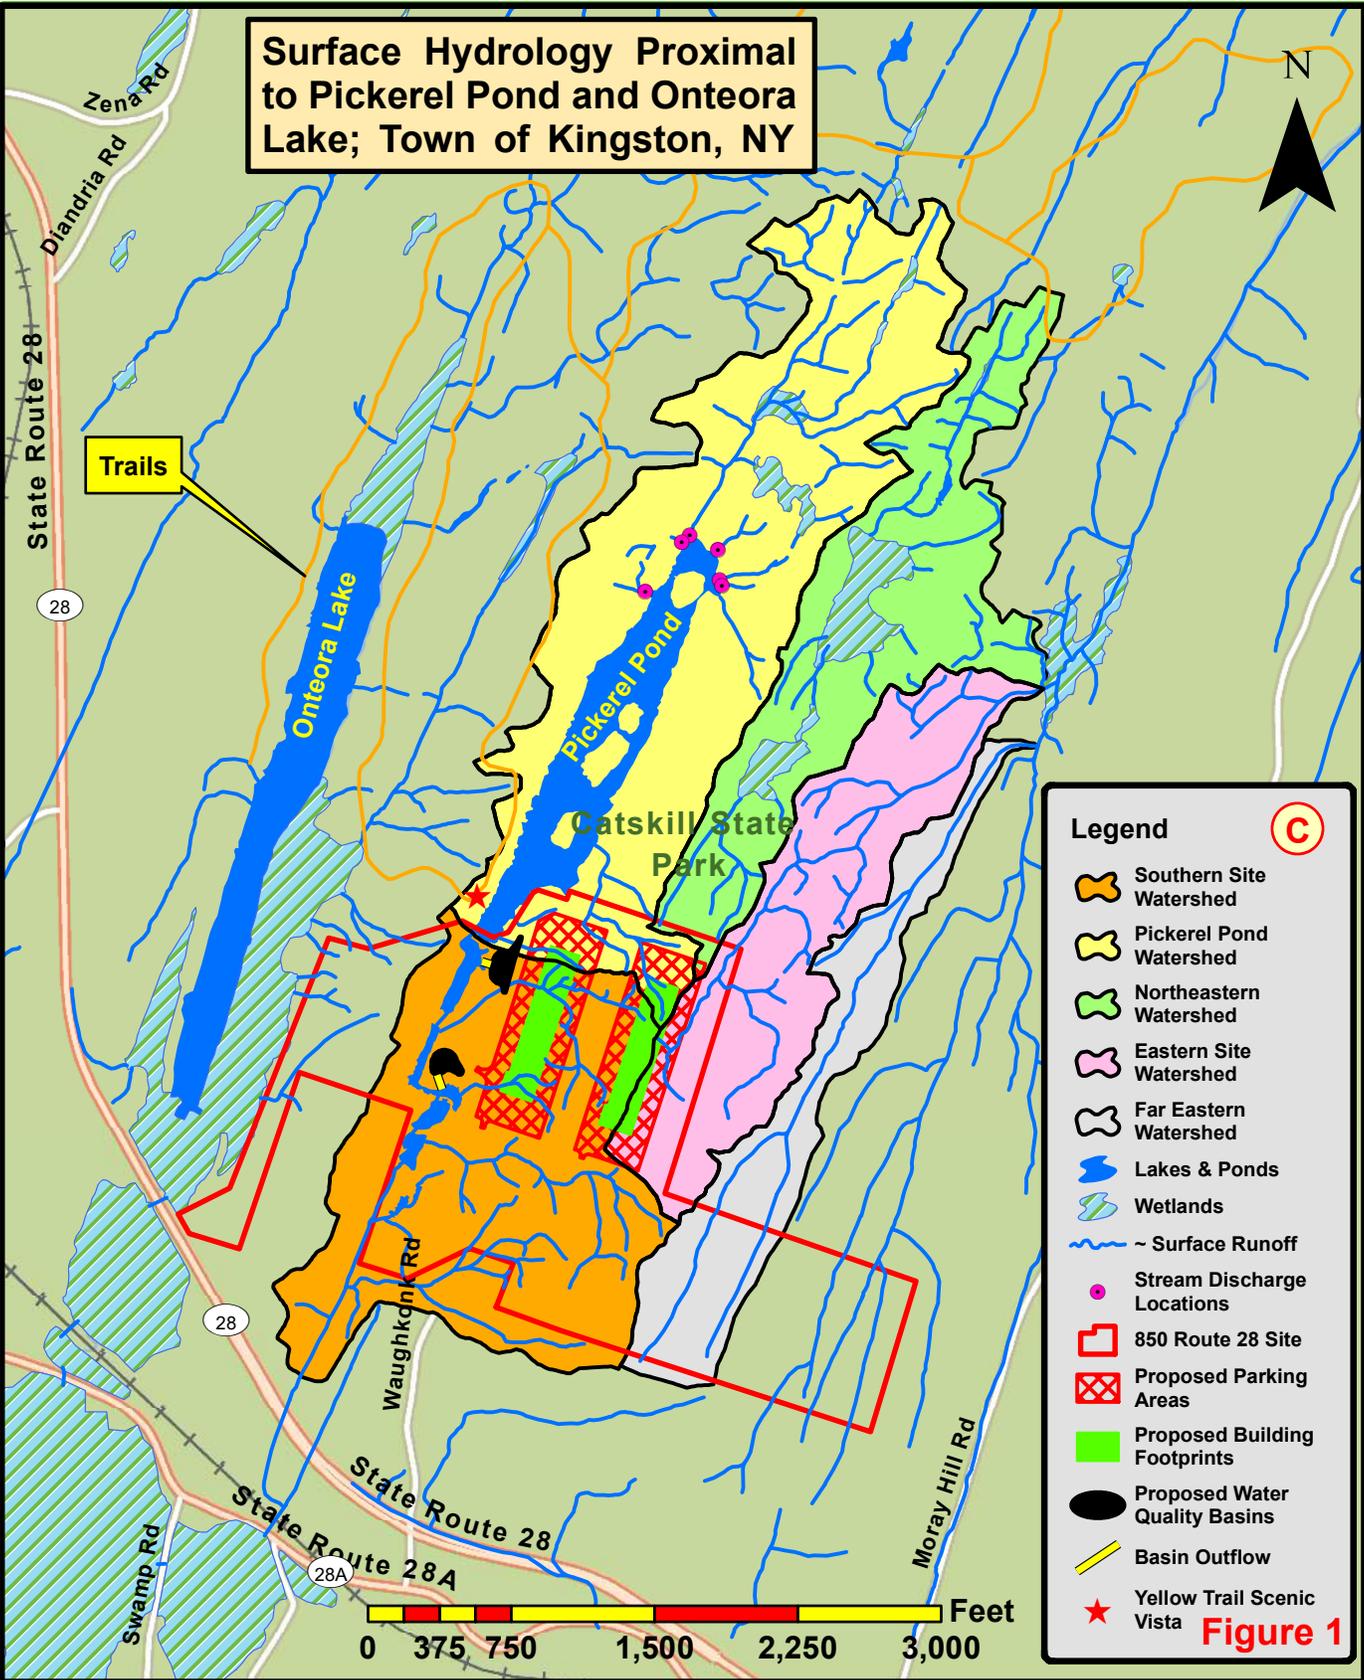
Figure 1

**Surface Hydrology Proximal to Pickerel Pond and Onteora Lake; Town of Kingston, NY**

- The proposed 850 Route 28 manufacturing facility straddles a hydrologic divide (see [Figure 1](#)). The southern site, Pickerel Pond, and Onteora Lake watersheds drain southward through a large wetland complex (NYS DEC Wetland KW-3) and then as Praymaher Brook alongside Thielpape Road until flowing into Esopus Creek.
- The northeastern, eastern, and far eastern watersheds drain northeastward as a stream until a confluence with the Sawkill northeast of Jockey Hill. The Sawkill then flows southeastward until it joins the Esopus Creek which then flows northward to Saugerties where it discharges into the Hudson River. The distance along the Sawkill and Esopus Creek between where project site drainage enters them is 10.3 creek miles.

- Figures 1 and 2 show the proposed 850 Route 28 project parking and building areas extending into the Pickerel Pond watershed. Field reconnaissance conducted on March 1, 2020 found only two of six streams actively flowing into the northeastern end of Pickerel Pond. Their combined discharge was estimated as only 25 gallons per minute (Photos 7 and 8). It is highly likely that there is no surface inflow during dry and drought times both here and immediately downstream of the earthen dam. This is important from the perspective of potential dilution and assimilation of chemical contaminants and stormwater runoff that the manufacturing facility may discharge into the waterway. The extreme headwater setting of the proposed industrial facility will, at times, have no natural streamflow.

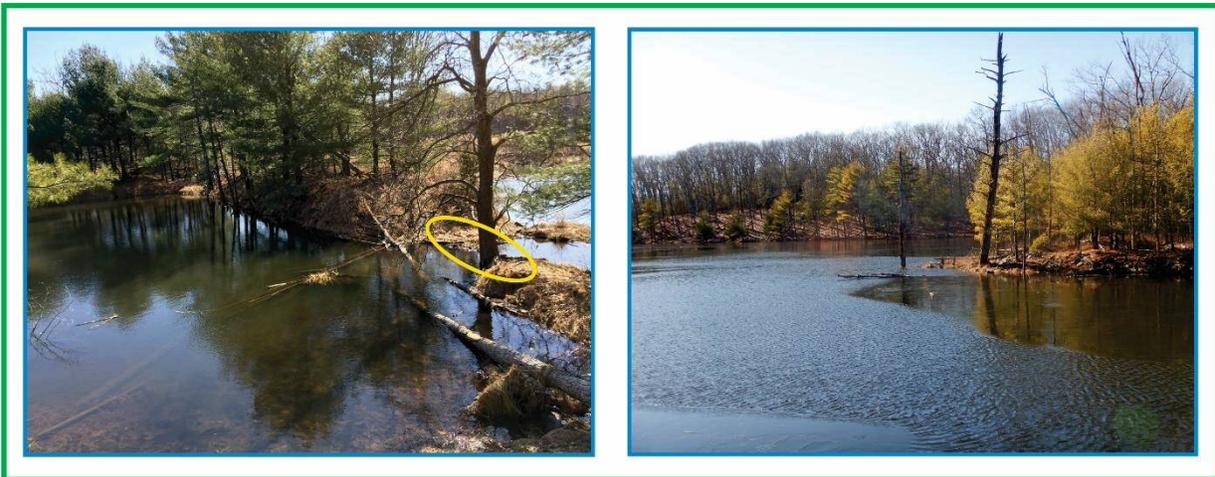
Photo 1. Earthen dam that impounds Pickerel Pond. Yellow ellipse: beaver dam currently elevates pond level. Also, see Photo 28 at the end of the report.

Photo 2. Island in Pickerel Pond.

- Pickerel Pond, at an elevation of approximately 460 ft msl, was formerly a large wetland prior to construction of an earthen dam across it sometime between 1972 and 1981 (based on review of historic topographic maps and orthoimagery). The dam extends about six feet above the surface level of Pickerel Pond, except near its eastern terminus where it has been breached (Photo 1). **Figure 2A** shows the location of this dam (highlighted by a white ellipse) that is not acknowledged in the Full EAF, Part 1, Section E.1.e. (Site and Setting of Proposed Action) that states that the 850 Route 28 project site does not contain an existing dam. For comparative purposes, **Figures 2B and 2C** show the same area on 2013 high resolution orthoimagery with and without 2-foot elevational contour lines. This dam-impounded 16.3-acre pond, inclusive of several islands, is now a gem within the Bluestone Wild Forest. Its habitat is actively used by beavers, waterfowl, turtles, and other species (Photos 5 and 6). At this time, the water level of Pickerel Pond is somewhat raised by a beaver dam (Photo 1). While project design would not impact this structure, it is likely that the dam requires periodic structural strengthening for long-term pond and habitat protection.

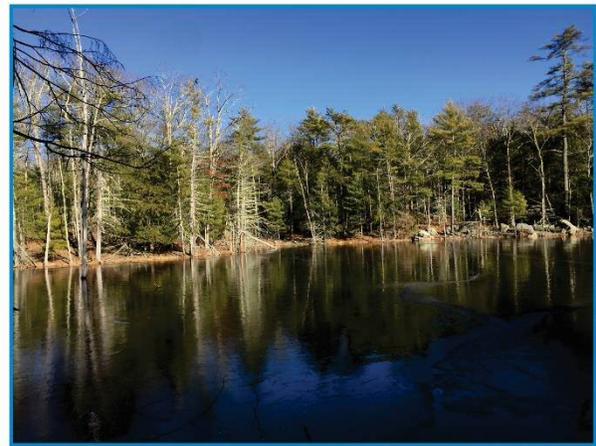
Photo 4. Northern Pickerel Pond.

- The southern boundary of the 87-acre Pickerel Pond watershed was drawn along the dam that separates it from the small 0.8-acre pond situated immediately downstream of it. Historic orthoimagery from 2009 shows significant water quality degradation (i.e., turbid water from sediment input) in this and other downstream ponds constructed directly within the waterway (Figure 1). These ponds were used as sediment settling basins for the bedrock quarry (Stormwater Pollution Prevention Plan [SWPPP]).
- North of the earthen dam that impounds Pickerel Pond, pristine water, islands, bedrock cliffs, logs, and trees provide healthy ecosystems (Photos 2, 3, 4, 5, and 6).

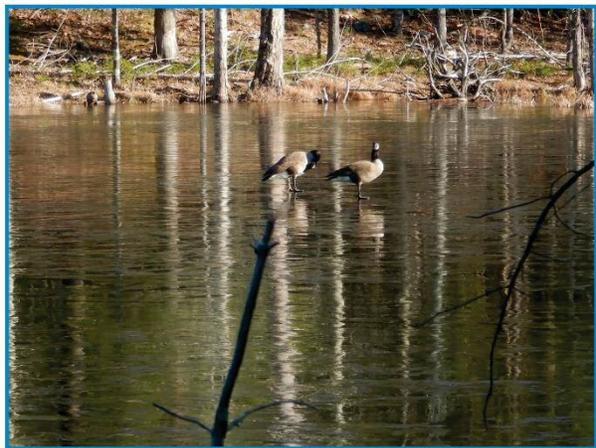
Photo 6. Geese on Pickerel Pond ice.

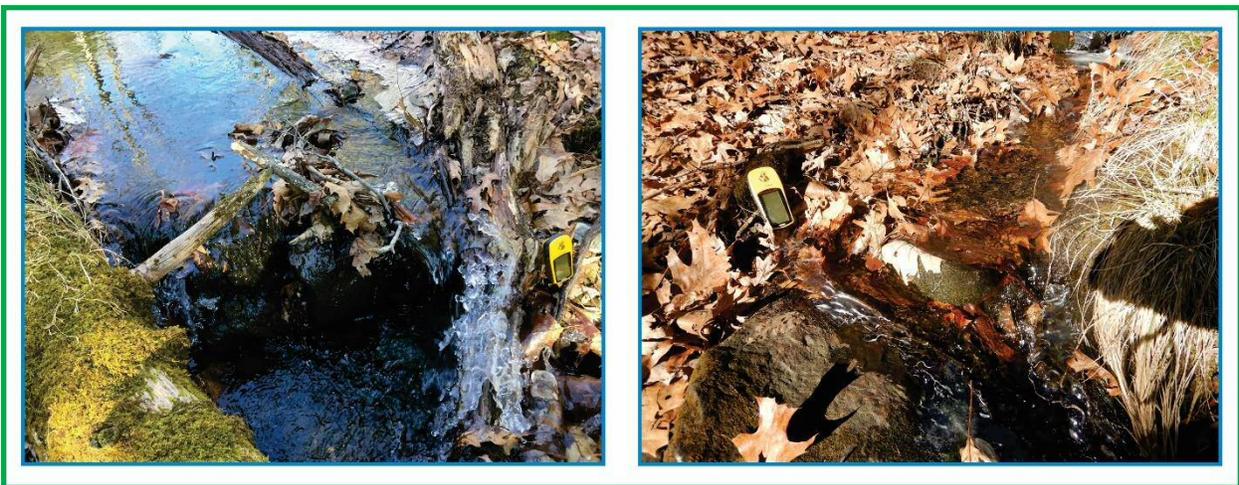
Photo 7. Low flow stream flowing into the northern end of Pickerel Pond on 3-01-20 (~20 gpm).

Photo 8. Low flow stream flowing into the northern end of Pickerel Pond on 3-01-20 (~5 gpm).

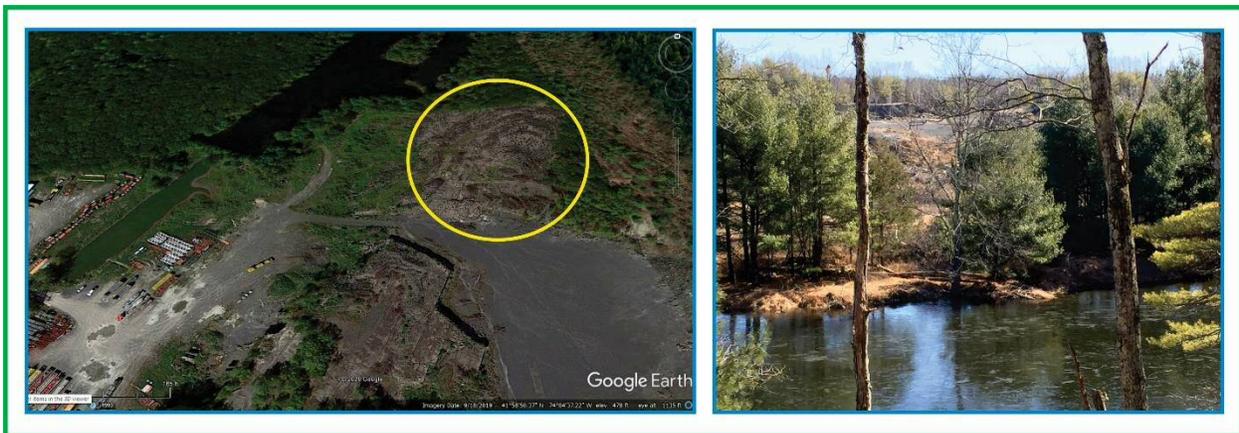
Photo 9a. Oblique view of quarry site looking NW. Felled trees are circled in yellow (9-18-19 imagery).

Photo 10. View of proposed industrial site from the Yellow Trail looking across Pickerel Pond.

- The proposed industrial site is visible from the yellow nature trail in the Bluestone Wild Forest. As the crow flies, a scenic trail vista location depicted by a star on Figures 1 and 2 is some 350 feet from the nearest proposed parking lot and 470 feet from the nearest building corner. A clear view would be afforded from hillslope to hillslope across the valley bottom (Pickerel Pond) which is about 28 feet below trail elevation (Photo 10).

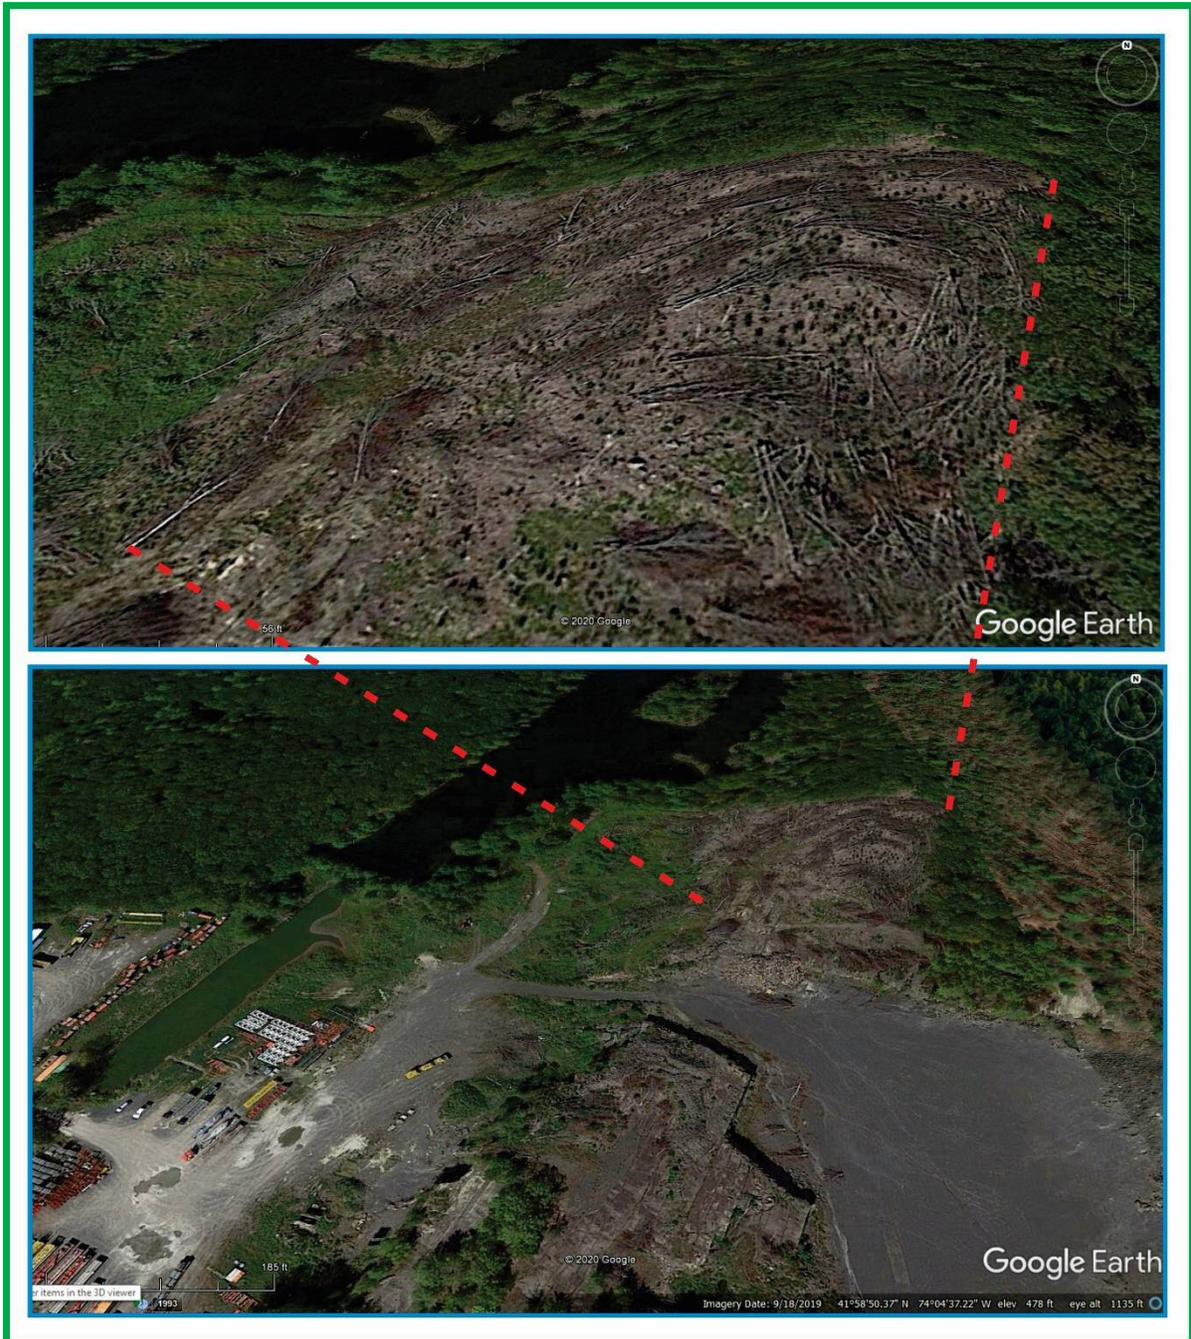
Figure 9b. Oblique photograph of cut trees on the project site.

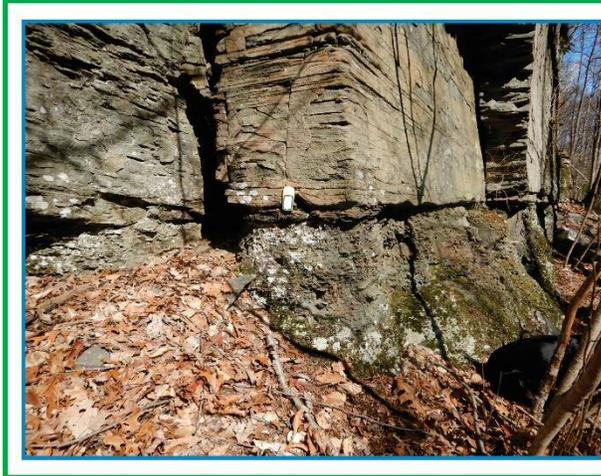
Photo 11. Sandstone overlying shale. Note planar vertical joints that provide groundwater flow pathways below ground.

- The Ashokan/Plattekill Formation sandstone and shale bedrock aquifer that Well BW-1 obtains water from is highly fractured (Photos 11 and 12). These photos show planar joints in outcrop exposures close to the project site. Groundwater moves within vertical fractures called joints and along horizontal bedding planes. Vertical joints in the bedrock, visible in 2016, 2013, and 2001 imagery, are highlighted in red on the bottom photograph of Photo 13. They serve as preferential groundwater flow pathways (i.e., secondary porosity). The fractures are closely spaced and very clearly show a preferred north-northeast to south-southwest orientation (N23°E to N27°E), perhaps overlying an unconfined upgradient portion of the bedrock aquifer. Further reference to Photos 11, 12, and 13 reveals cross joints nearly perpendicular to the major joint set (~ N64°W) that interconnect north-northeast (NNE) to south-southwest (SSW) joints.

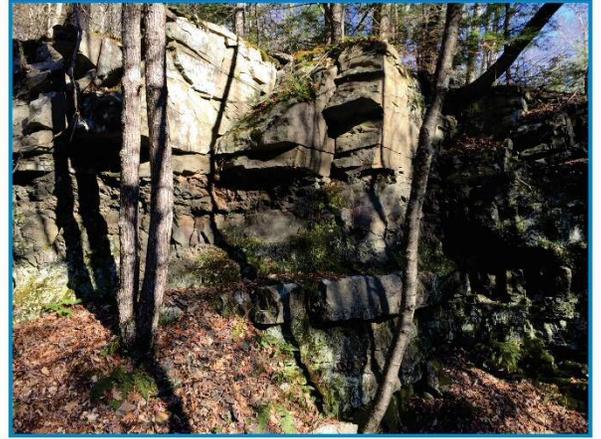
Photo 12. Note vertical joint faces.

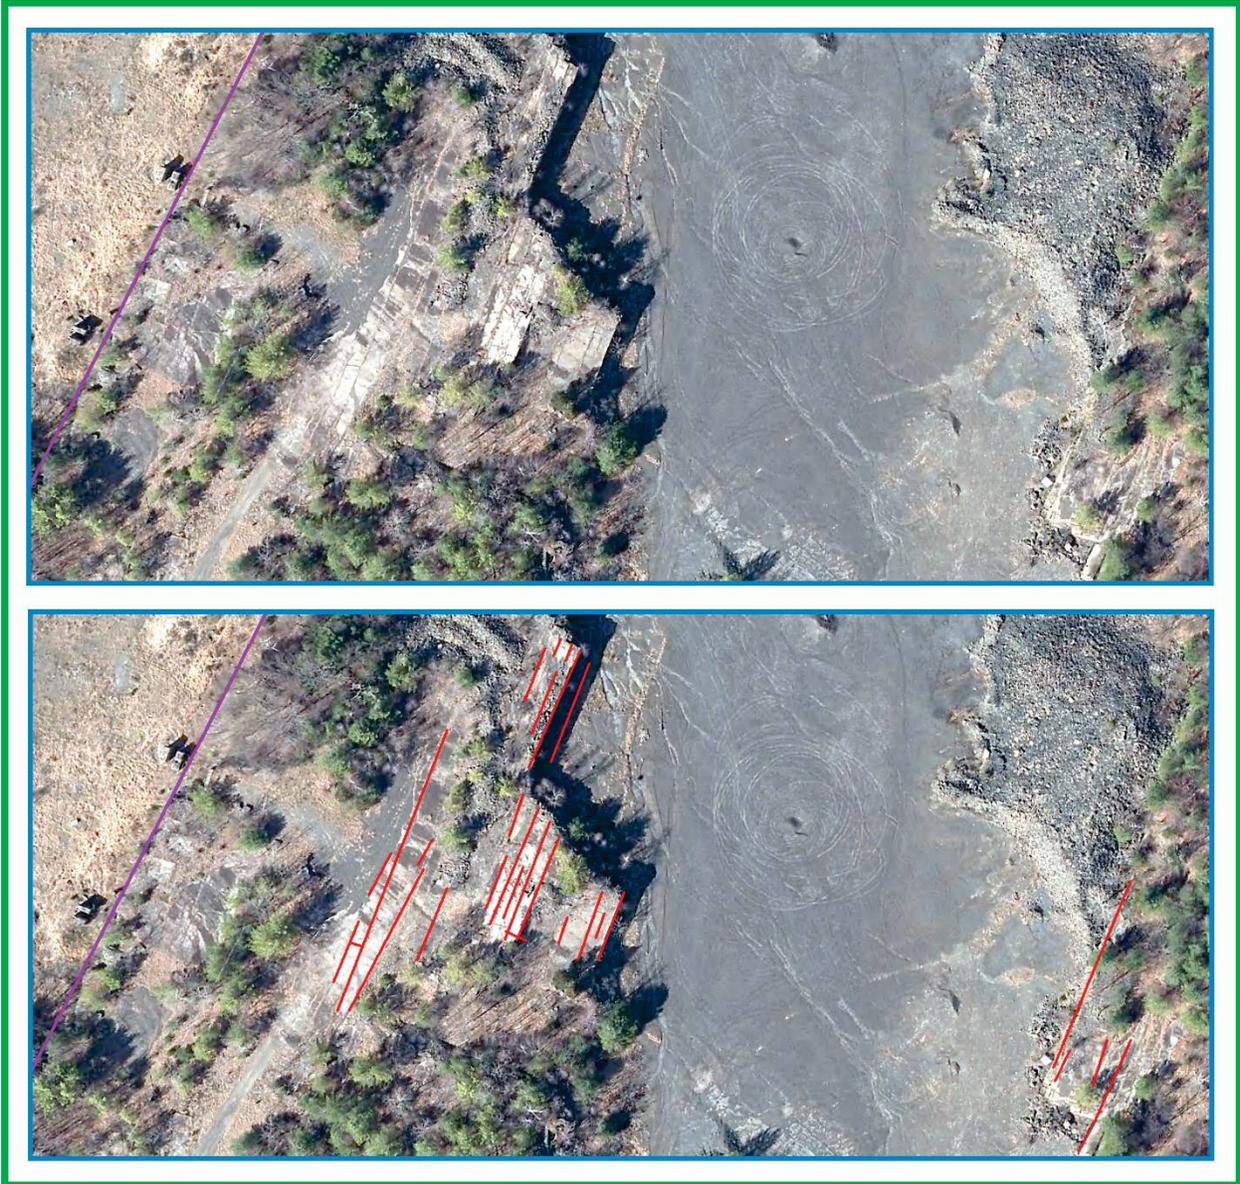
Photo 13. Closely spaced and interconnected north-northeast to south-southwest joints, as well as nearly perpendicular joints, extend far below ground surface where they transmit groundwater to streams, lakes, ponds, and wells. Figure 3 shows the location of the red highlighted fractures.

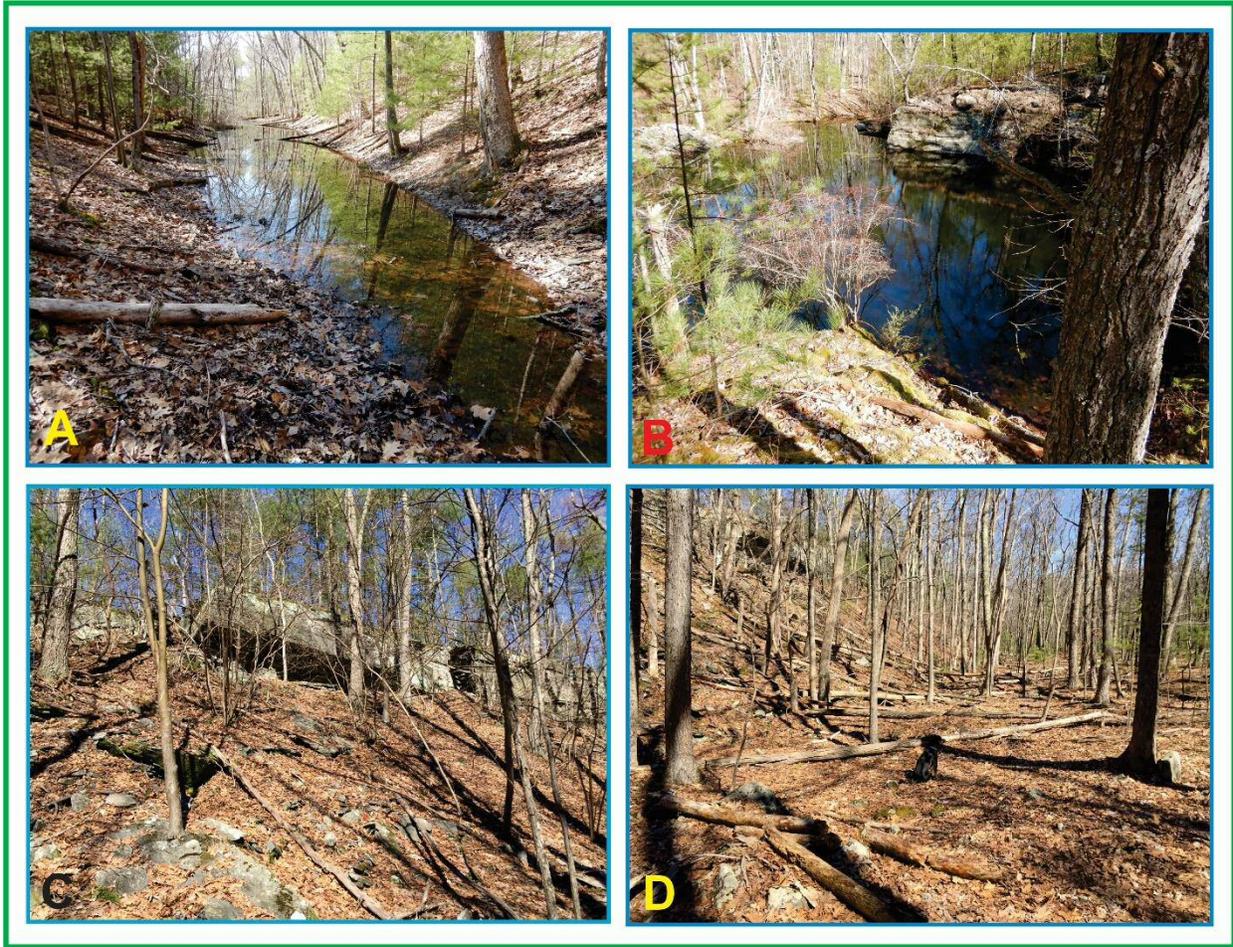
Photo 14. Pickerel Meltwater Channel: A) Pooled water along U-shaped channel invert, B) Relict bluestone quarry, C) Sandstone caprock at channel top, D) Channel floor near NNE terminus.

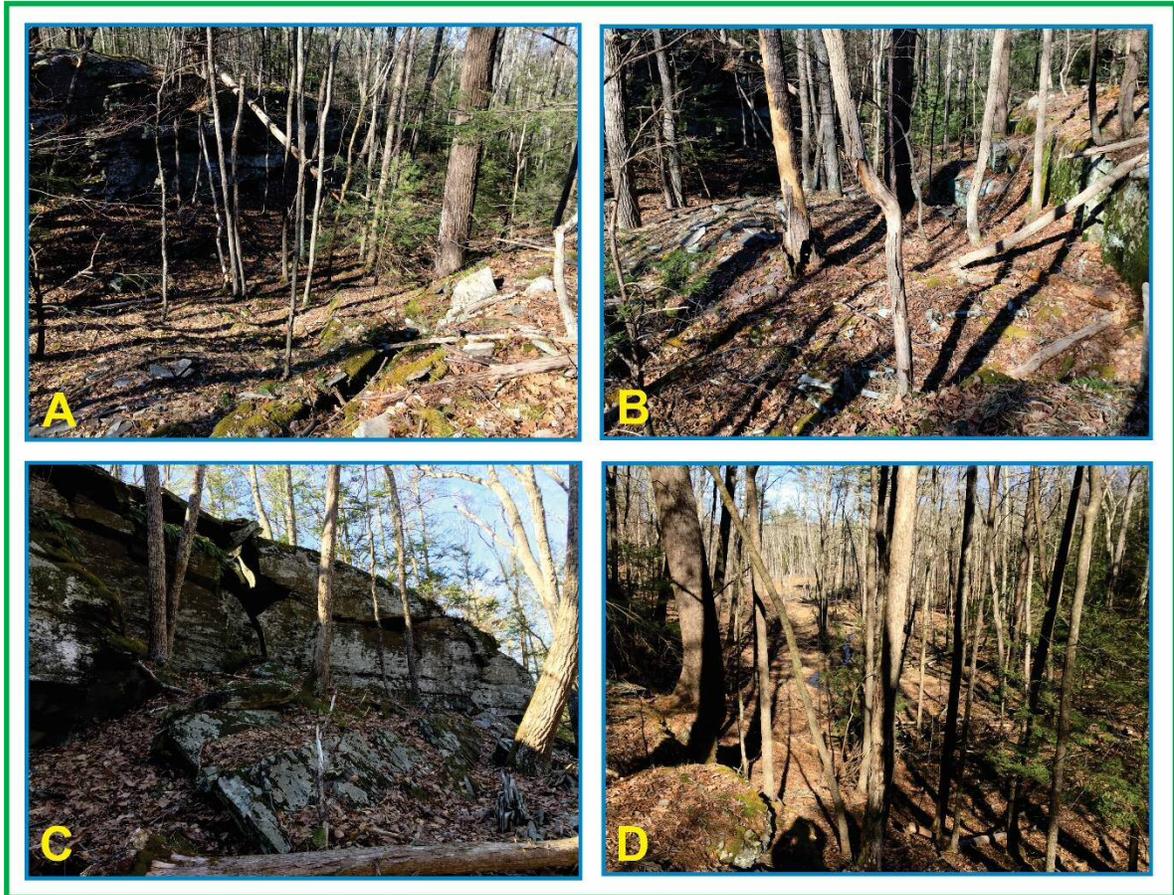
Photo 15. Onteora Meltwater Channel. All photos of the NNE end of the Onteora Channel where glacial meltwater entered and carved the channel. A) and C) West bedrock wall of the channel, B) East bedrock wall of the channel, D) Looking north-northeastward from the channel floor down a steep slope that now drains to the Sawkill. This entire slope area was formerly filled with a glacial lake.

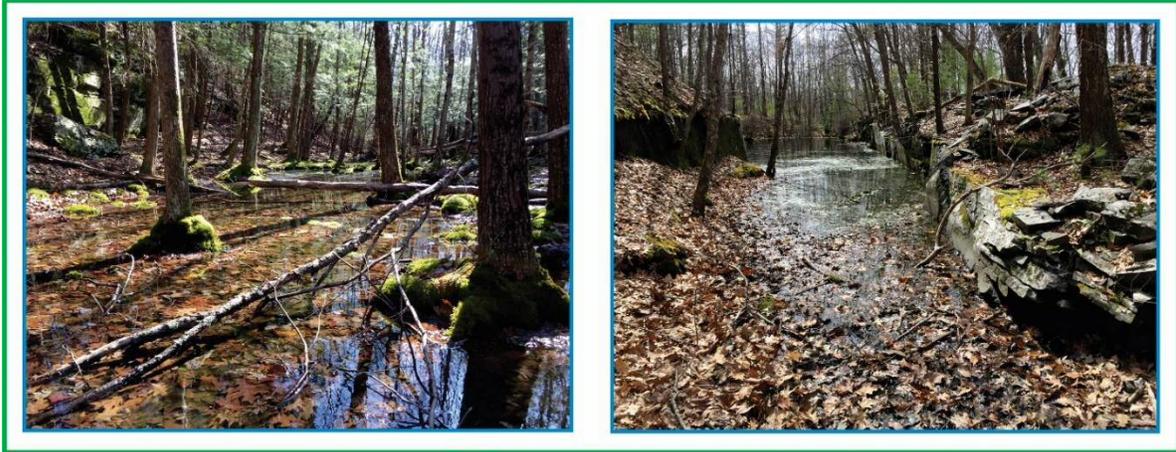
Photo 16. Steep-sided valley bottom interpreted to be a relict glacial meltwater channel that once drained a glacial lake SSW out of the Sawkill drainage. No bluestone quarrying occurred to bedrock cliffs. Ice-cold meltwater once roared through this gorge (Onteora Meltwater Channel).

Photo 17. Trees and a quarry pond used by ducks and spring peepers attest to natural restoration over time. Both channels are linear for over 1,200 feet.

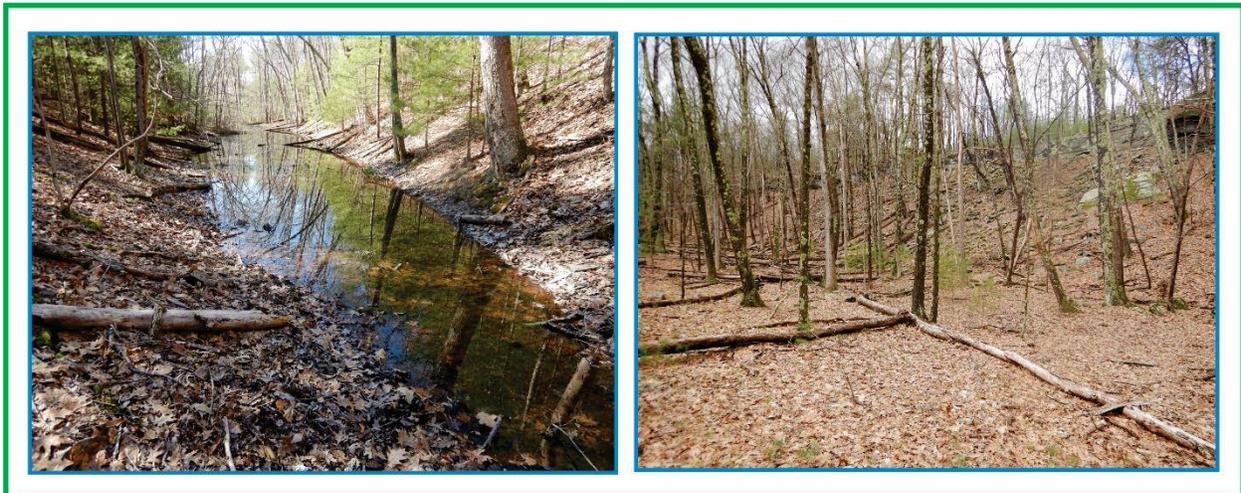
Photo 18. U-shaped channel bottoms and sides provide evidence of glacial sculpting.

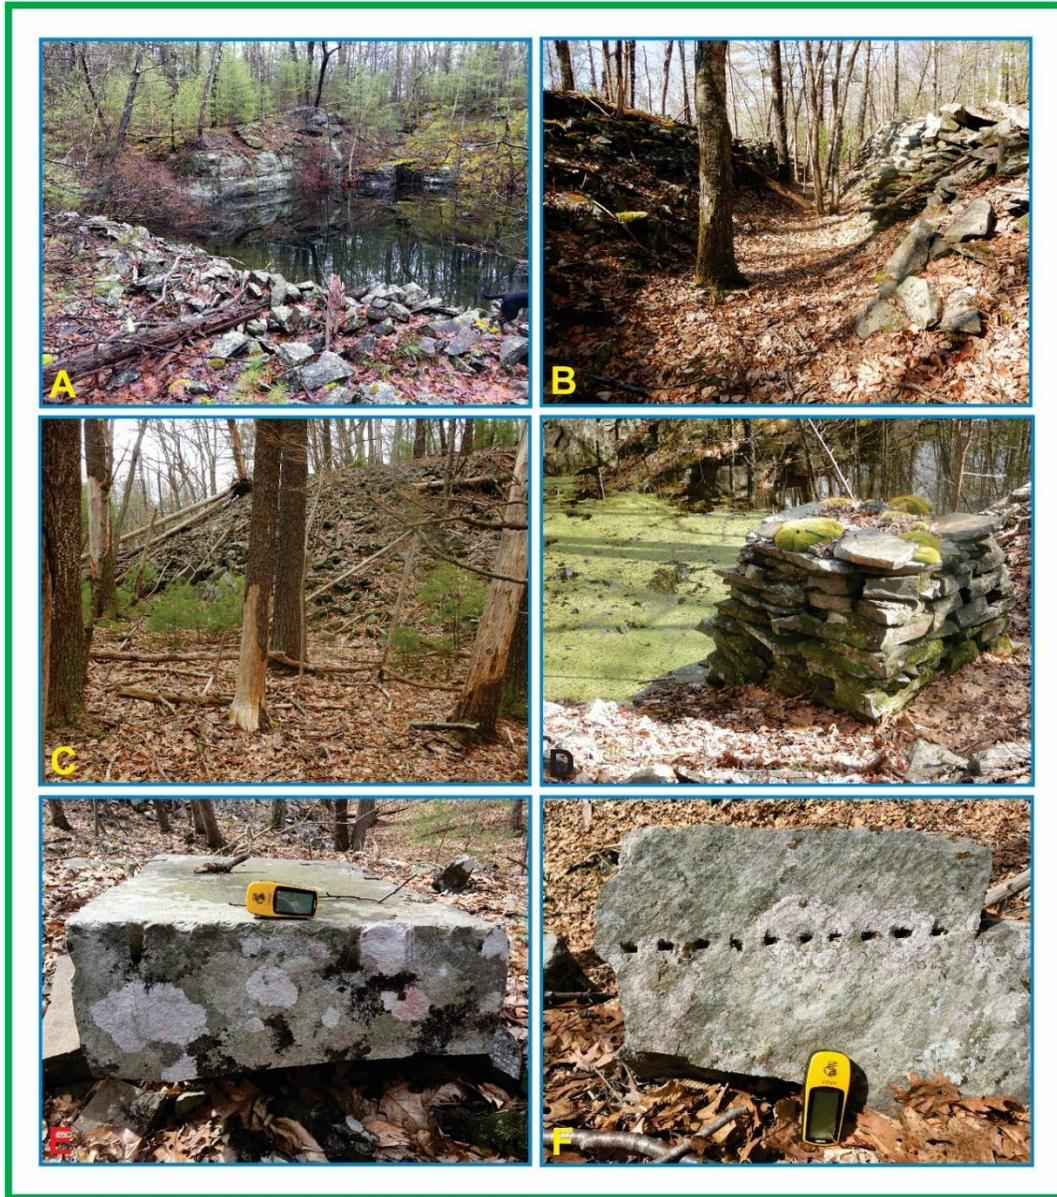
Figure 19. Quarry workings in Bluestone Wild Forest.

- Bluestone Wild Forest is riddled with evidence of historic bluestone (i.e., sandstone) quarrying. Quarry workers exploited sandstone cliffs exposed along meltwater channels, low cliff faces, bedrock mounds, and even massive boulders on top of knolls. For example, historical quarry works are present along both the east and west side of Pickerel Pond, with three quarry zones extending into the 850 Rt 28 project site. Enormous rubble piles associated with many of these quarry workings provide evidence that it was difficult to extract quality stone of desired thickness and extent, even with vertical fractures and horizontal bedding planes to guide extraction (Photos 19A, 19B, 19C). Relict forest workshop areas reveal evidence of methods used to cut sandstone blocks to desired specifications (e.g., nail holes and round drill holes used in the shaping process, Photos 19D, 19E, 19F). Detailed cultural assessment of these features, workshop areas, and their locations is warranted.

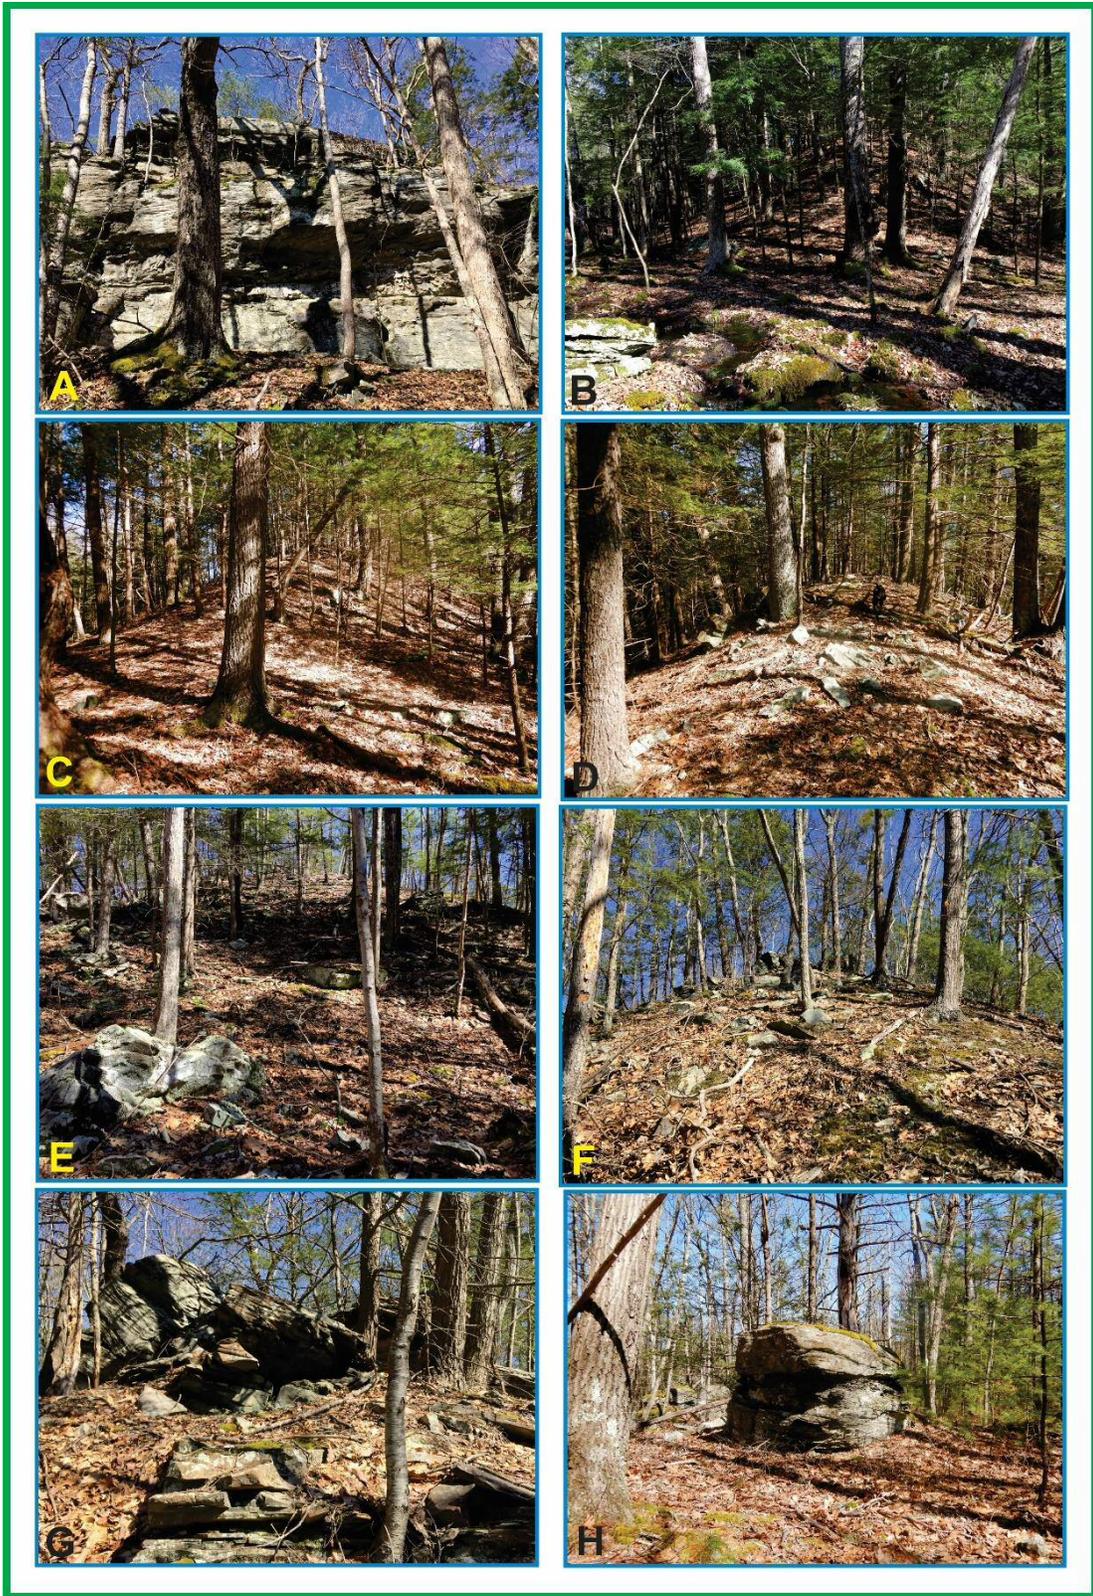
Photo 20. Glacial features present in the Morey Valley. Refer to Figure 5 and report text to correlate photograph letters with physical locations. H is a glacial erratic on top of the streamlined bedrock plateau depicted on Figure 4.

- A most unusual glacial feature is present between the boulder drumlin and the streamlined bedrock plateau (Figures 4 and 5 and Photos 20E, 20F, 20G, and 21A to 21E). This is a conical, boulder-rich, debris mound some 300 feet in diameter and 60 feet high. It is not streamlined by glacial movement, as are the other nearby glacial features. Two possible mechanisms of formation seem plausible. One holds that its development post-dates the subglacial sculpting that formed the other features, forming as a powerful on-glacier (supraglacial) stream poured boulders and other debris into a crevasse or moulin (sinkhole in the glacier) immediately south of the bedrock promontory. This would have occurred during the final downwasting or melting stage of the glacier, well after drumlin deposition.

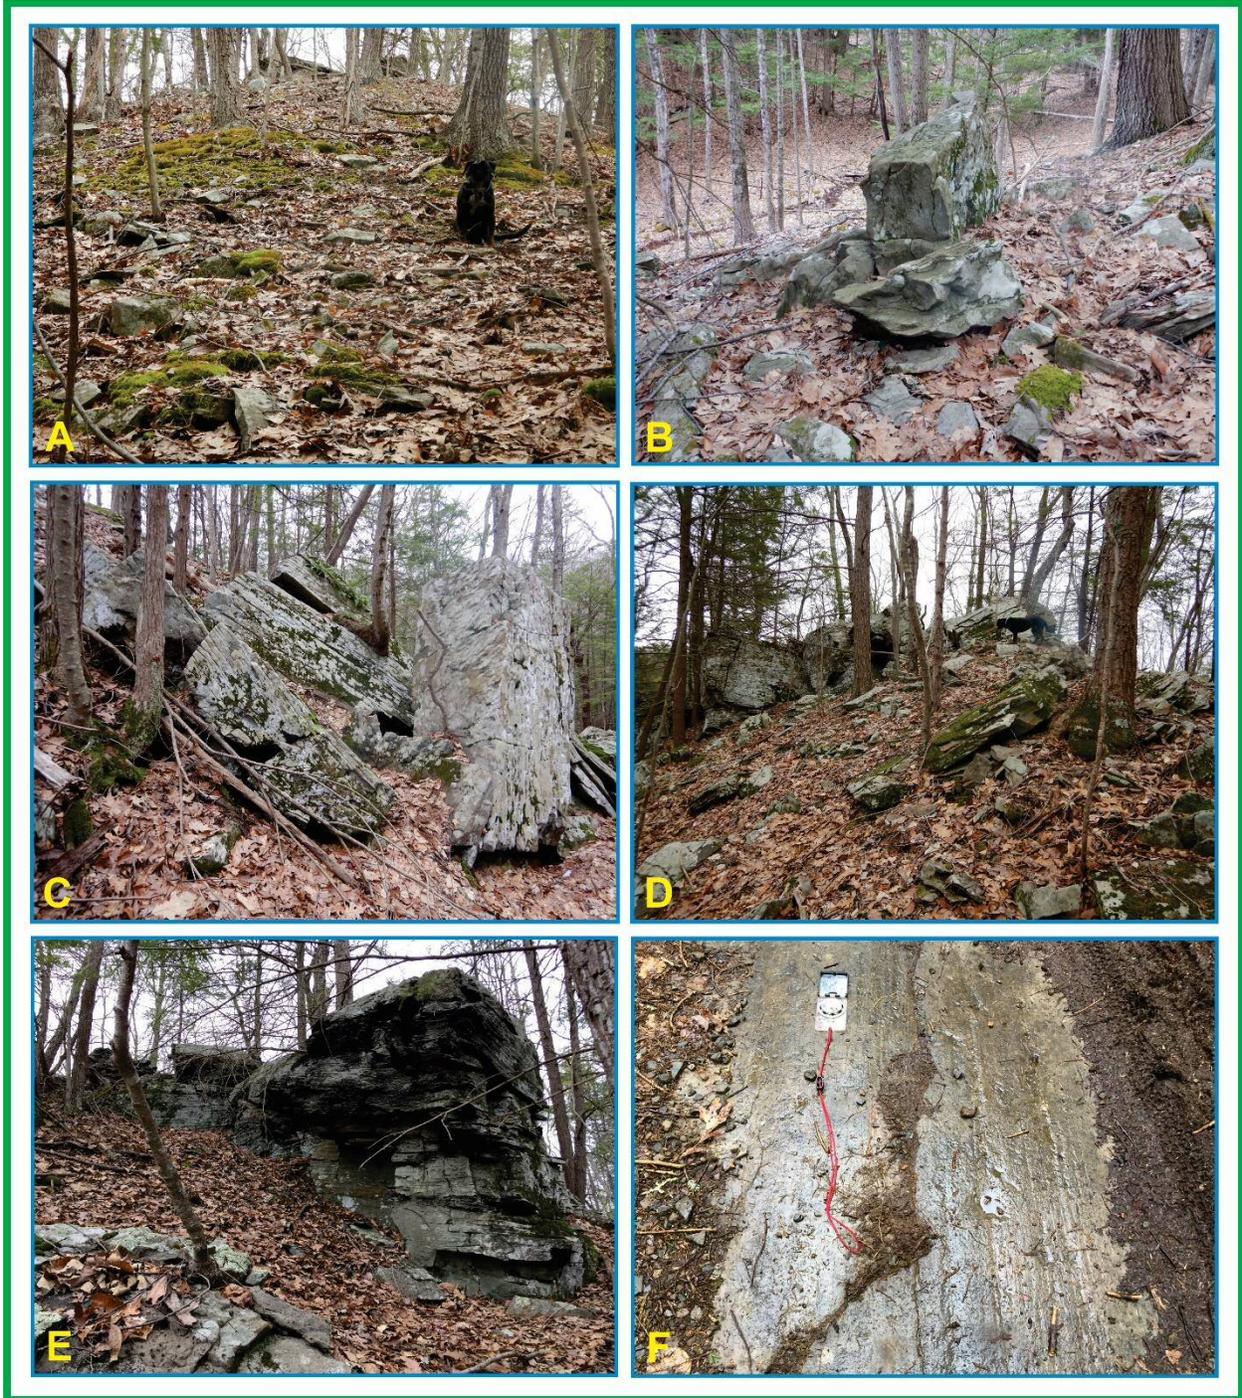
Photo 21. A through E. Debris, boulders, and a remnant segment of bedrock that, together, form the conical mound portrayed on Figure 5. The small segment of bedrock on top of the mound serves as a protective caprock. Scree of various sizes covers what may be a bedrock mound core. F. Etched striations in bedrock formed by rocks bound in ice grinding against the rock as a glacier moved.

- A second more likely mechanism of formation that may account for the shape and composition of the conical feature holds that the core of the cone is largely a remnant of the intact bedrock cliff situated about 125 feet to the north (Figure 5). Reference to Photographs 21D and 21E show large bedrock boulders and, quite likely, a small intact segment of bedrock at the top of the conical mound. Reference to Photographs 21A, 21B, and 21C show that while much of the debris material is relatively small in size, that much of it is comprised of massive bedrock blocks. The physical position of these blocks is consistent with downslope gravity sliding, much of which may have occurred within a subglacial cavity present beneath glacier ice. This cavity would have been positioned directly south of the streamlined bedrock blockage as glacier ice arced downward off the bedrock plateau. Under this scenario, boulders, rocks, and sediment from within debris-rich basal ice would have dropped out into the cavity as glacial melting occurred. The V-shaped space between the crest of this conical mound and the bedrock cliff to the north, versus an elongated drumlin-like shape, provides evidence that both subglacial and bedrock material fell and slid downward into an ice-free cavity – allowing development of the cone-shaped mound. Similarly, massive sandstone boulders are present immediately south of two other bedrock promontories situated further to the west (Figure 4).

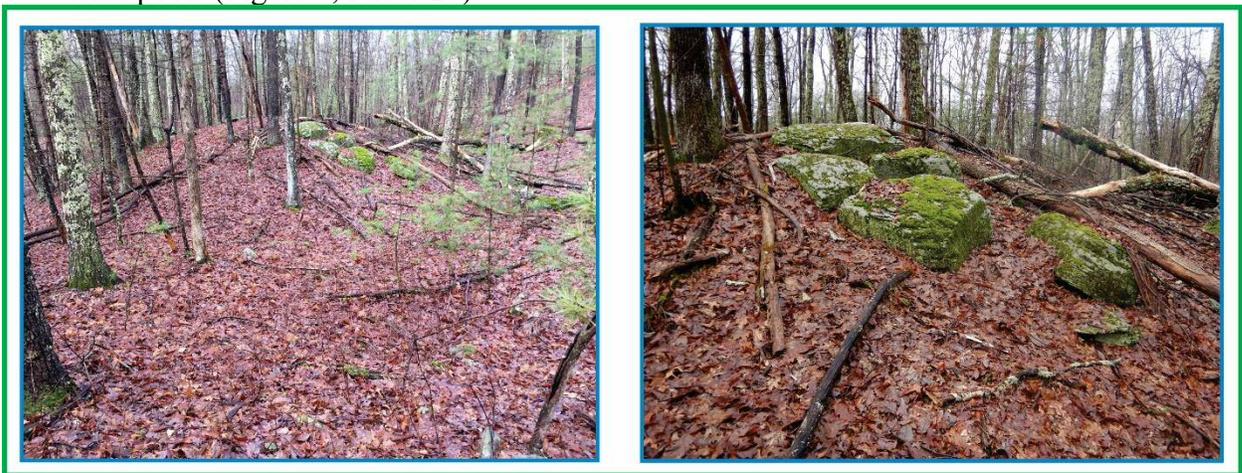
Photo 22. Circular mound near the southern terminus of a meltwater channel. See Figure 6 for location. Large boulders commonly top these mounds.

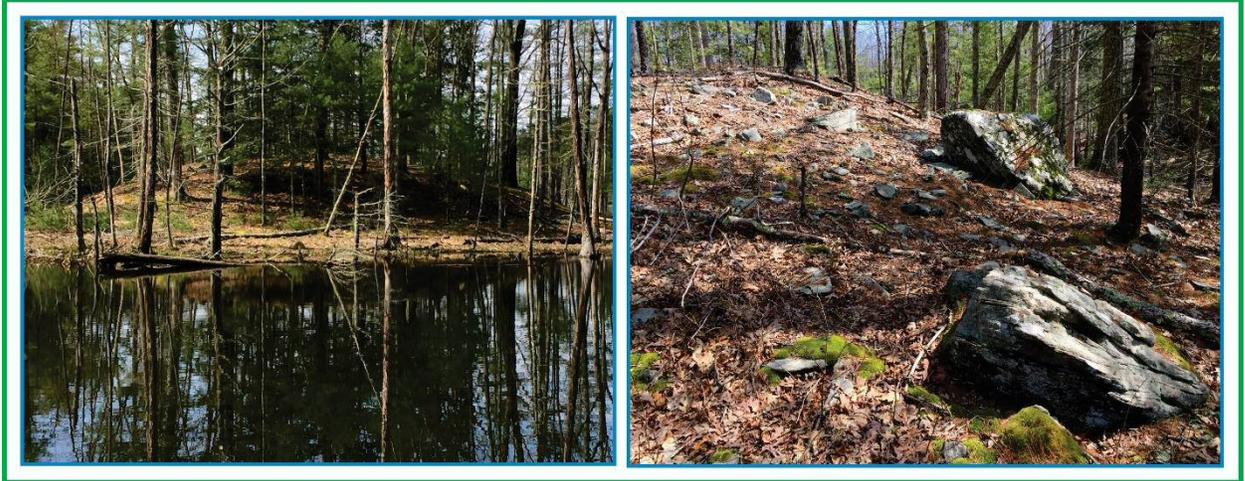
Photo 23. Well-rounded knoll within and near the northern end of Pickerel Pond. With few exceptions, most of the boulder material on this mound is of small and medium size.

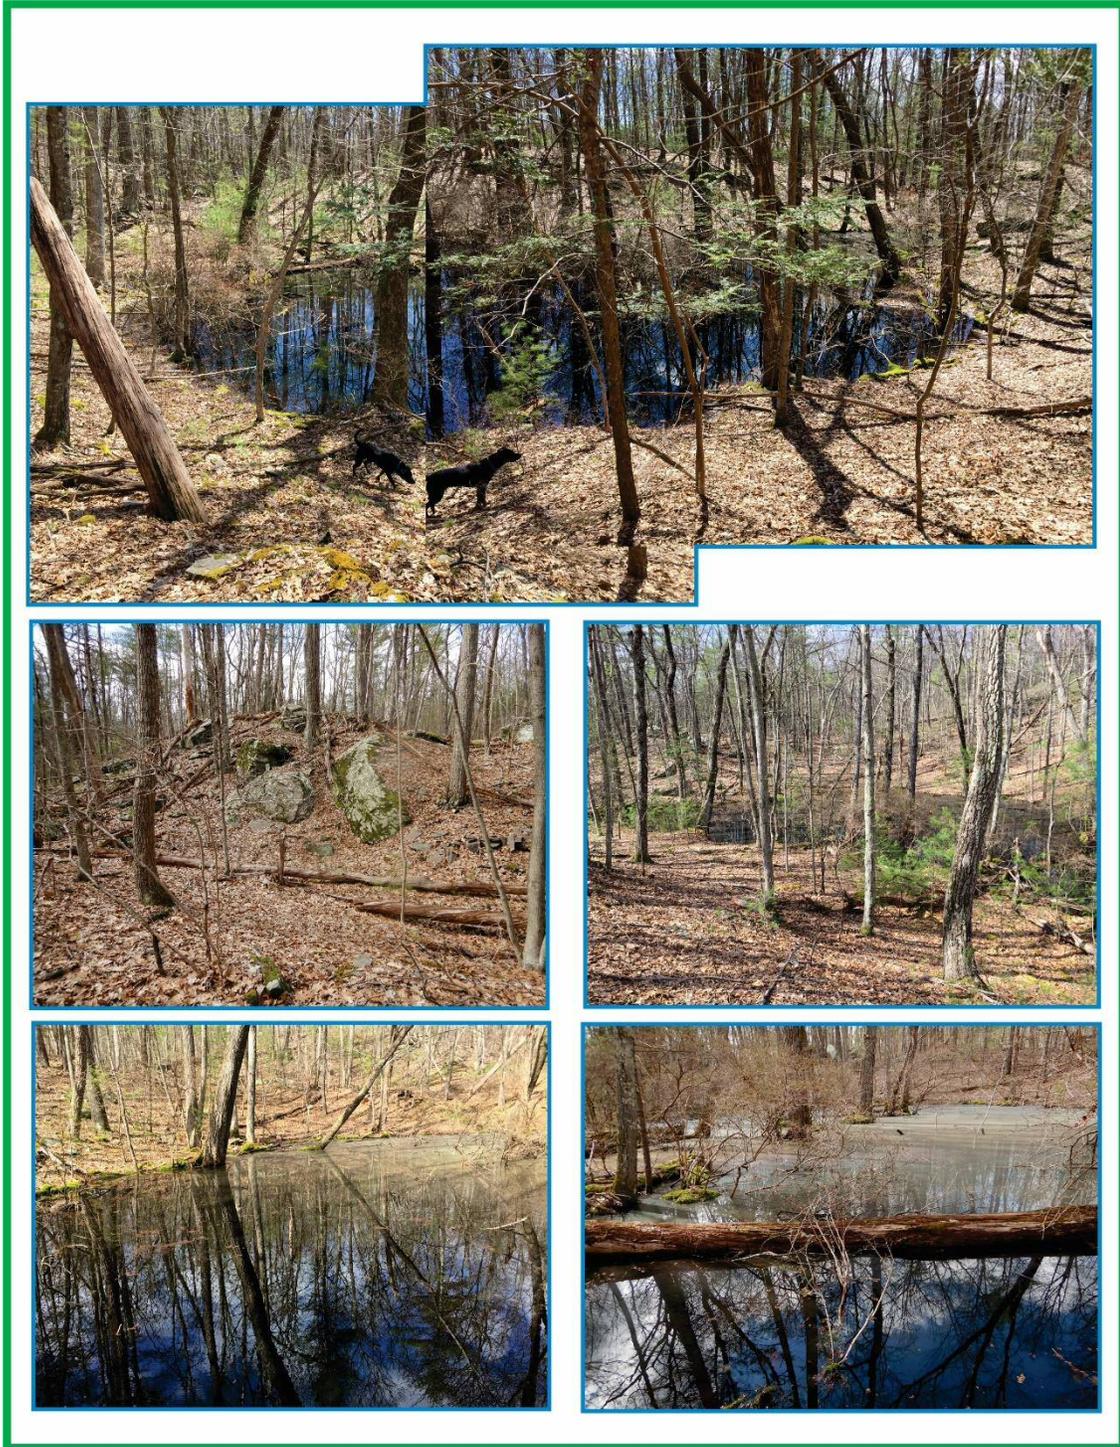
Photo 24. Turtle Kettle hole and nearby boulder-rich mound. Note hummocky knoll hills surrounding the kettle pond. Nearby elevations are labeled on Figure 6.

- Some of the depressions or kettle holes amidst rounded mounds (knolls, Figure 6, Photos 22 and 23) have either permanent ponds (e.g., Turtle Kettle: Figure 6, Photo 24) or seasonal vernal pools (Figure 6, Photo 25).
