# HydroQuest

May 5, 2020

## **Surface Hydrology, Hydrogeology, Bluestone Quarries, and Glacial Geology Proximal to Pickerel Pond and the Proposed 850 Route 28 Manufacturing Facility**

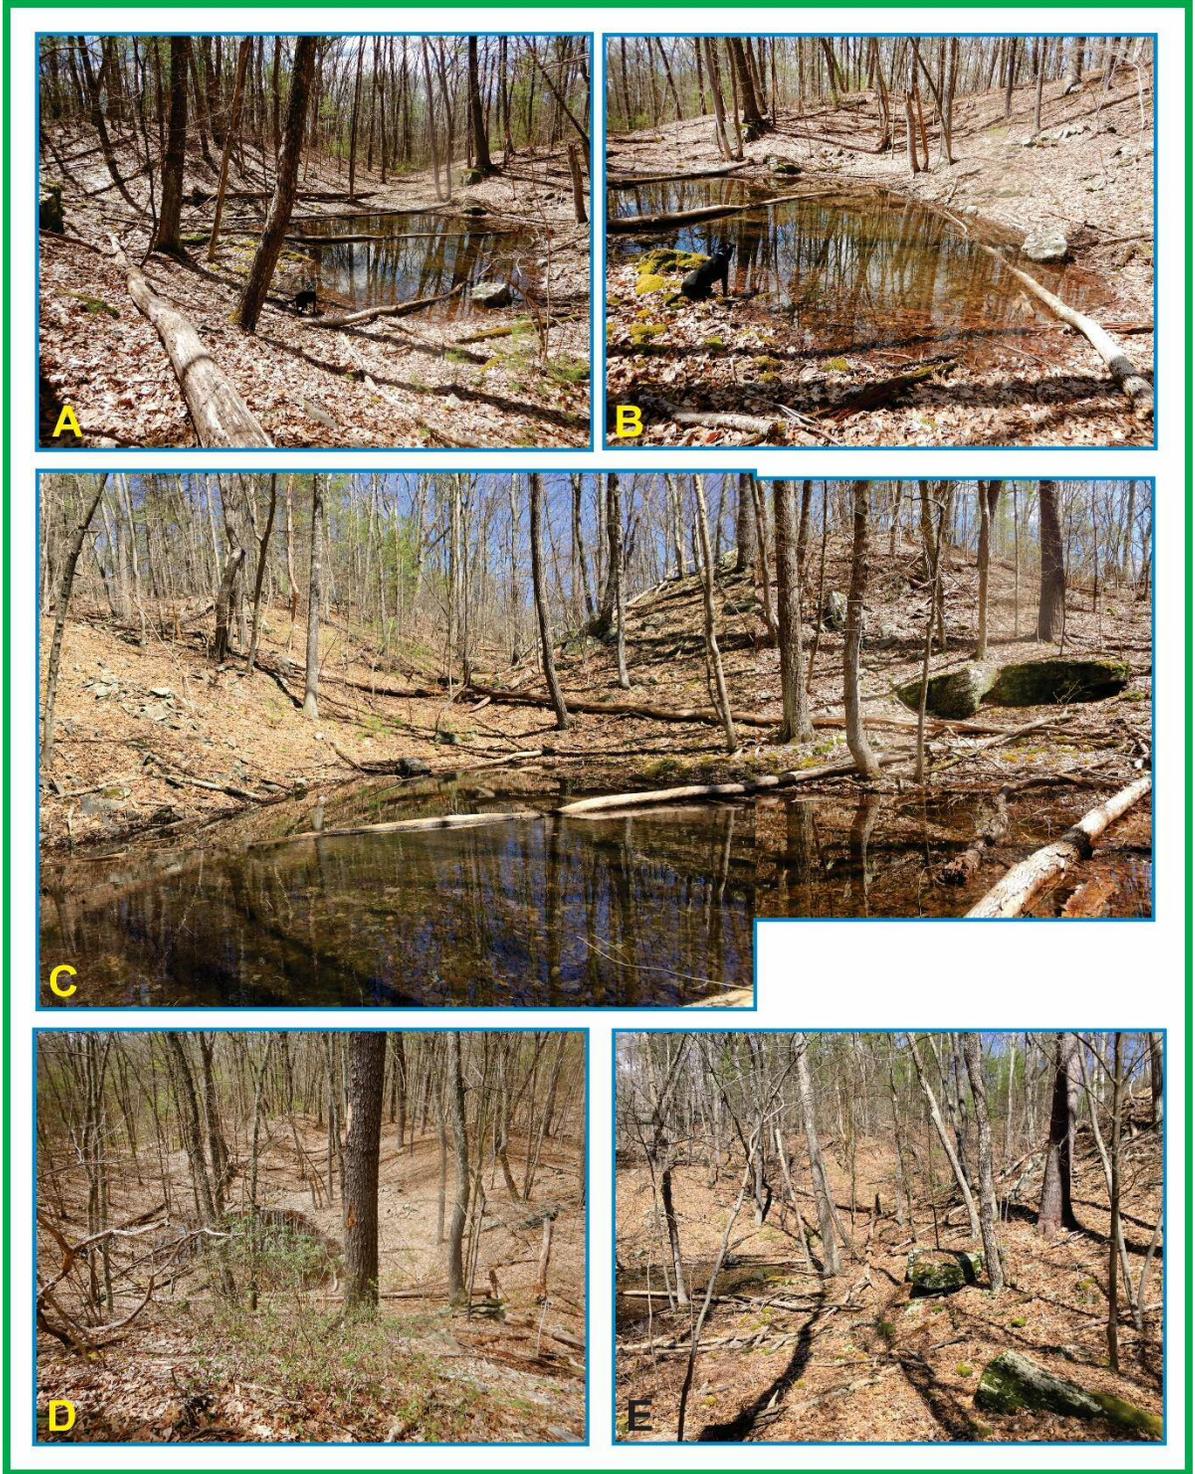
Photo 25. Vernal pool surrounded by hummocky mounds. See Figure 6 for elevations. The top of the mound to the east of the kettle pool (C above) is about 40 feet above the invert of the pool. D and E look down on the kettle pool from the 40-foot mound.

- Some of the depressions or kettle holes amidst rounded mounds (knolls, Figure 6, Photos 22 and 23) have either permanent ponds (e.g., Turtle Kettle: Figure 6, Photo 24) or seasonal vernal pools (Figure 6, Photo 25).

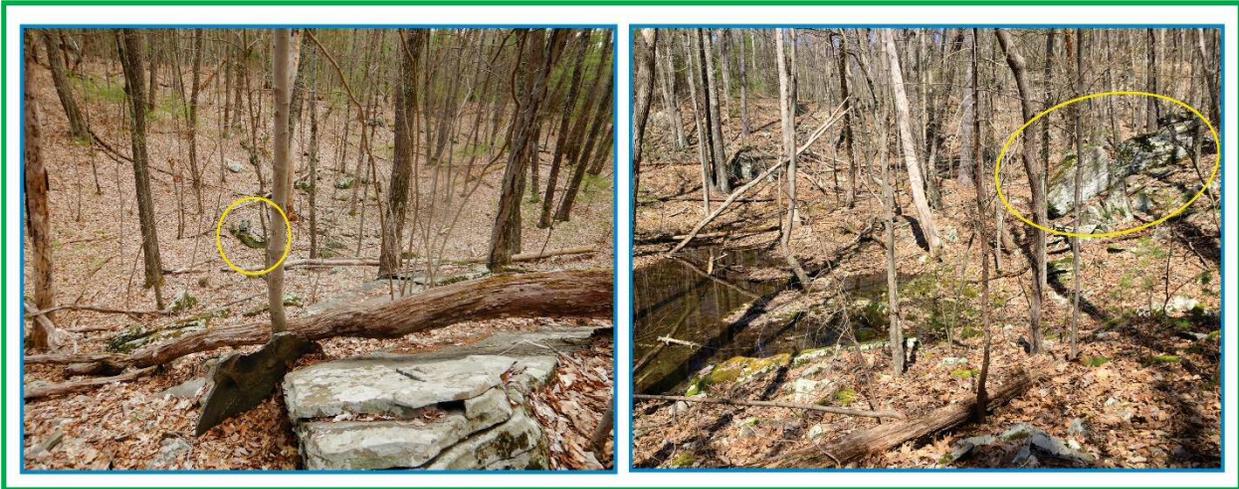
Photo 26. Steeply angled boulders on the slopes of knolls. The yellow circle in the left photograph encircles a large boulder in a kettle. A seasonal kettle pool is visible in the right photograph.

- Large boulders present on knolls are often angled downslope. This probably reflects preferential ice melting away from darker colored drift atop glacier ice (Photo 26).

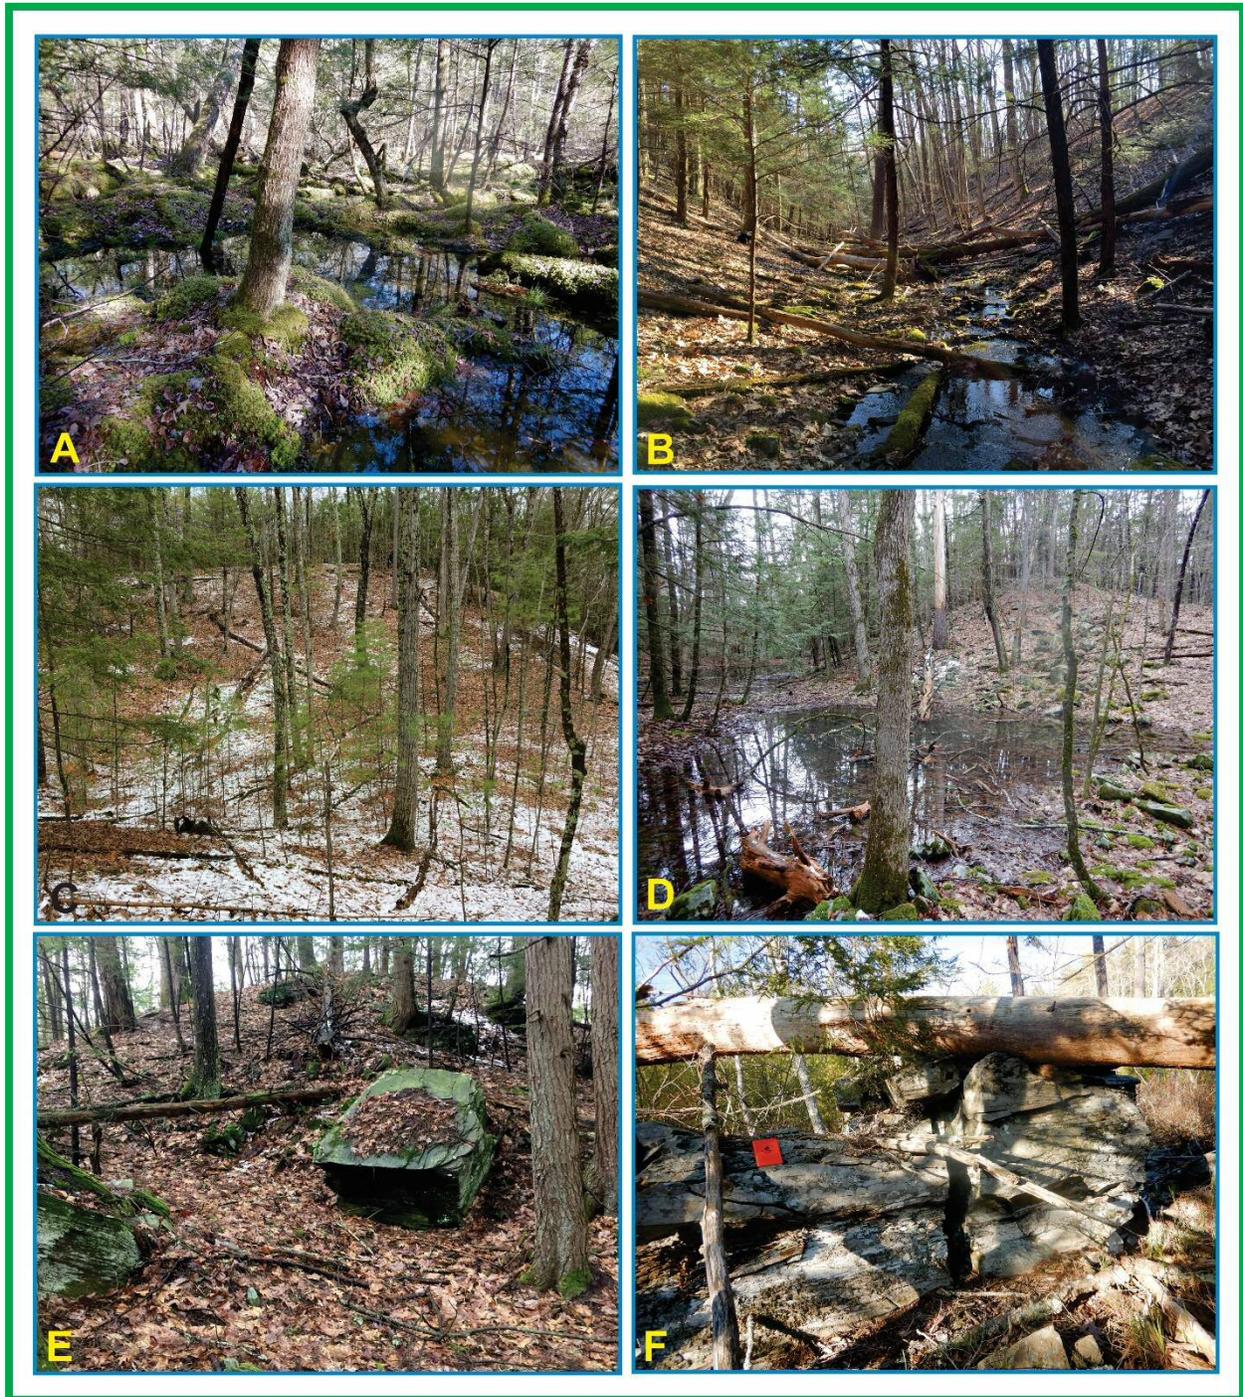
Photo 27. Bluestone Moraine area proximal to the yellow trail. A) Wetland near the northern end of the Bluestone Tunnel. B) Midway within the Bluestone Tunnel with missing overhead glacier ice. C) Steep-sloped knoll in moraine. D) Bouldery knoll and kettle pool at the southern base of the prominent Bluestone Moraine ridge. E) Rounded knoll just northeast of the Ontario Lake wetland. F) Six-foot high boulder on small island within the Ontario Lake wetland (Figure 4).

- The area situated south-southwest of the southern ends of the Onteora and Pickerel channels provides a particularly good example of the outward distribution of glacially plucked boulders. Not only are there bouldery knolls and kettles present, but toward the southern end of the yellow trail there is a chaotic zone of hummocky terrain or moraine that at first glance appears difficult to make sense of. This area is referred to as an end moraine, which is an accumulation of drift (i.e., a mix of rocks, boulders, and sediment of varying sizes) built along a margin of a glacier. Here, it is comprised of a complex of at least three arcuate ridges, each of which marks a temporary terminus of glacier ice. The arcuate red-dashed line here (Figure 4) traces the southernmost, and most pronounced, ridge labeled “*Bluestone Moraine*”. It has a particularly steep-sided southern face ending in kettle pools (Photo 27D). Assorted knolls and small kettles in this area on and between moraine ridges form the irregular, boulder-riddled, landscape. Note the boulder-rich mound just southwest of the trail’s southern end (Photo 27E). Boulders throughout the moraine document the southwesterly transport of angular boulders, extending into the wetland margin of Onteora Lake (Photo 27F). Near here, a valley is present north of where the yellow trail crosses a small stream. This incised valley cuts directly through the outermost (aka southern) hummocky moraine. Once, this prominent “*Bluestone Tunnel*” channel (Figure 4, Photos 27A and 27B) served as a primary drainageway beneath melting, stagnant, glacier ice. At that time, this would have been the entrance to a sculpted ice cave that extended almost one-half mile northward.

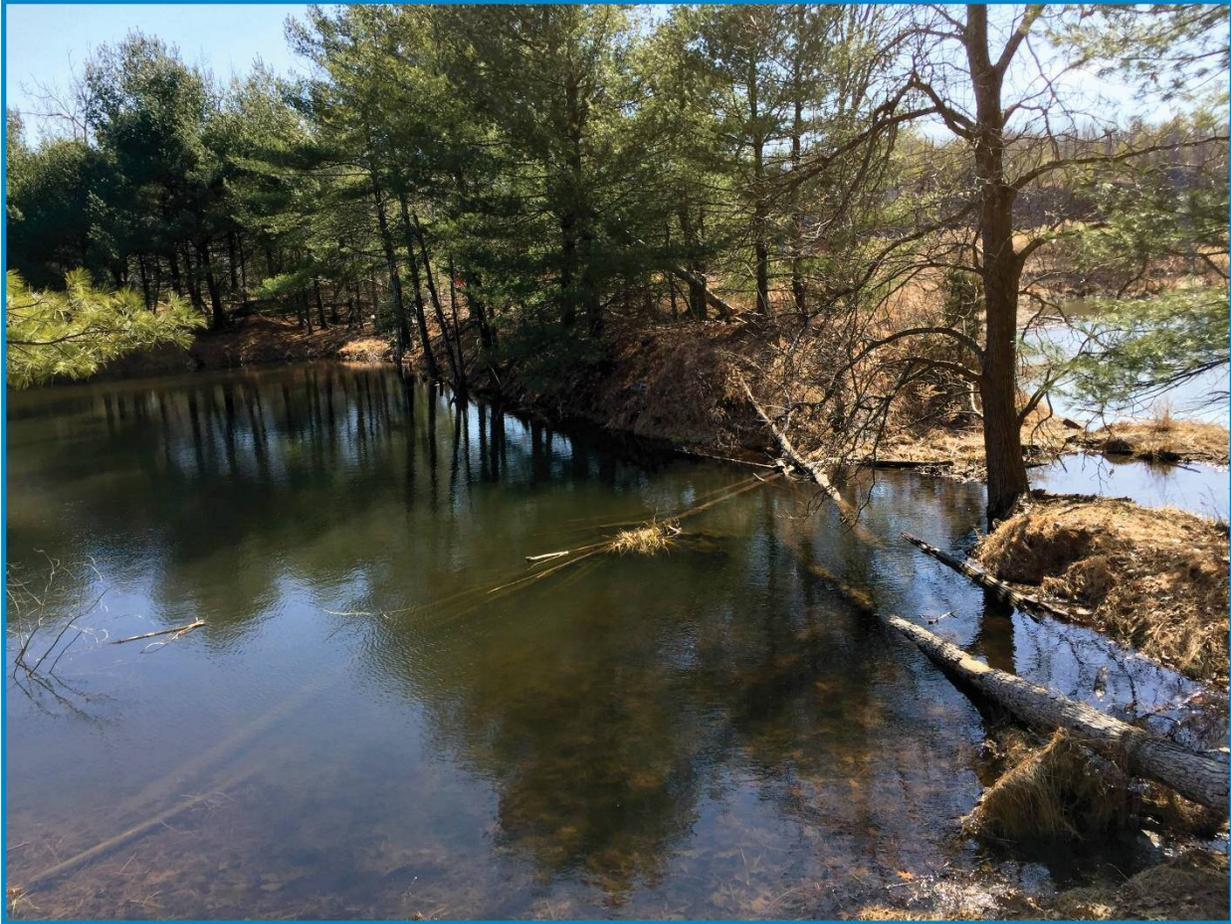
Photo 28. Earthen dam impounding Pickerel Pond. The outlet water elevation is currently enhanced by beavers. With the exception of the dam, 16.3-acre Pickerel Pond is on New York State lands.

- The health of the Pickerel Pond ecosystem relies on limited and episodic surface water inflow and groundwater baseflow into it. Under dry and drought conditions, removal of 8 percent of the tributary watershed for project construction could have adverse environmental impacts to the pond's ecological health. Similarly, potential reduction in groundwater baseflow to Pickerel Pond resulting from groundwater pumping may compound hydrologic and biologic impacts to the existing, vibrant, ecosystem. With the exception of the dam impounding it (Photo 28), Pickerel Pond is on New York State lands.
