Preliminary Cultural/Archaeologic Resource Investigation: Hemlock Quarry

Location: Bluestone Wild Forest, Town of Kingston, New York State. See NYS location map below and Figure 1. This general area is referred to as Stony Hollow.

Prepared by HydroQuest for Catskill Mountainkeeper and Woodstock Land Conservancy

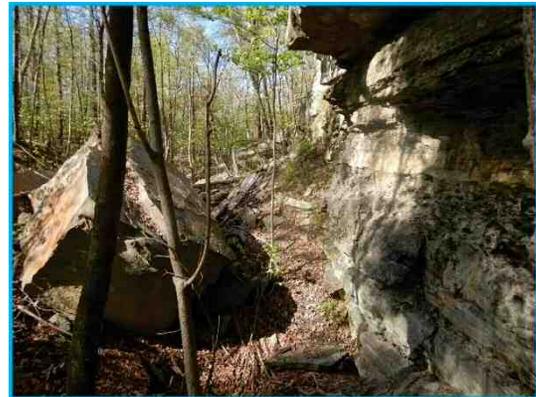
Large bedrock block (left) fallen from cliff face.

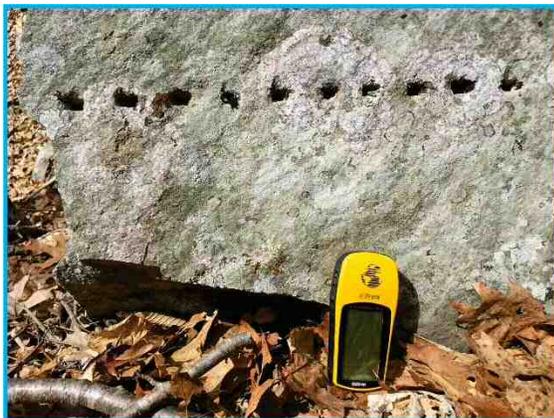
Cultural Significance: “Hemlock Quarry” is the largest relict bluestone quarry within the Bluestone Wild Forest and the only one where progressive bedrock cliff removal occurred over a long distance, probably with the aid of horse drawn derricks. The large scale of the operation here was favorable because competent, well-bedded, sandstone (aka bluestone) beds are underlain by a thick sequence of weak shale beds - making bluestone extraction economically viable (i.e., by dropping or swinging massive sandstone blocks onto staged work areas for shaping and transport). The quarry’s continuous

cliff length of about 1100 feet provides an exceptional cultural resource and opportunity to reconstruct and interpret historic stone quarrying methods (some of which cannot be gleaned from historic sources); moreover, this long cliff is adjacent to workshop areas, an historic quarry road, and building structures formerly part of the quarry’s working operation some 170 years ago. This quarry has great value as an archaeologic resource and, importantly, for educational, historic, and ecotourism venues.

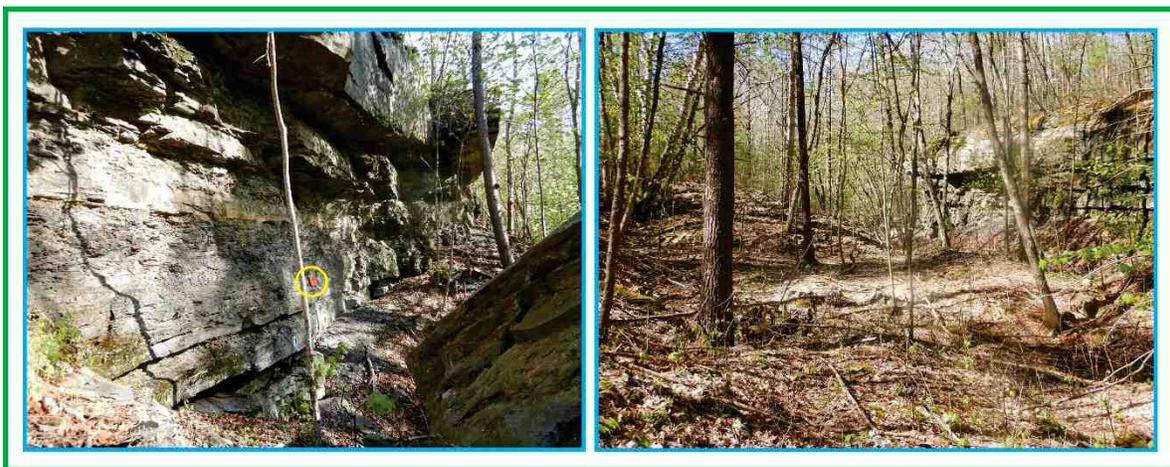
Worked Hemlock Quarry cliff faces looking north-northeast (left photograph) and south-southwest (right photograph). Note raised quarry rubble pile on left side of right photograph.

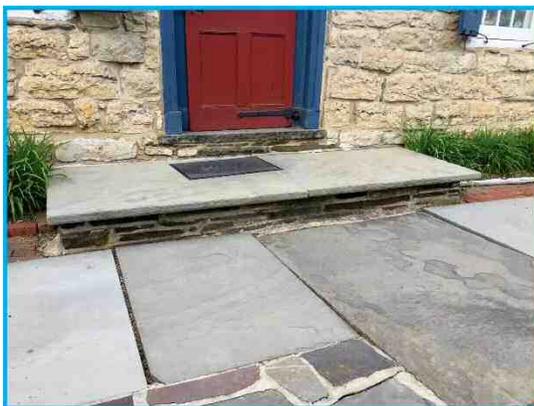
The exposed basal portion of the Hemlock Quarry cliff face on New York State lands is comprised of 19 feet of interbedded shale and sandstone (Photograph A below). Weak, friable, shale (Photograph B below) made extraction of some thin sandstone layers relatively easy work. A thick sandstone caprock overlies the underlying weaker shale-rich geologic beds (approximately 11 feet thick). The massive competent nature of these upper sandstone beds made them well-suited for flagstone sidewalks, doorway sills, and building construction. A 7.6-foot thick

sandstone block that was formerly directly above the underlying weak shale beds is shown on the top of page 1 and in photographs C and D below. Note the dashed red lines that accent thin bedding plane partings that the quarry workers exploited.

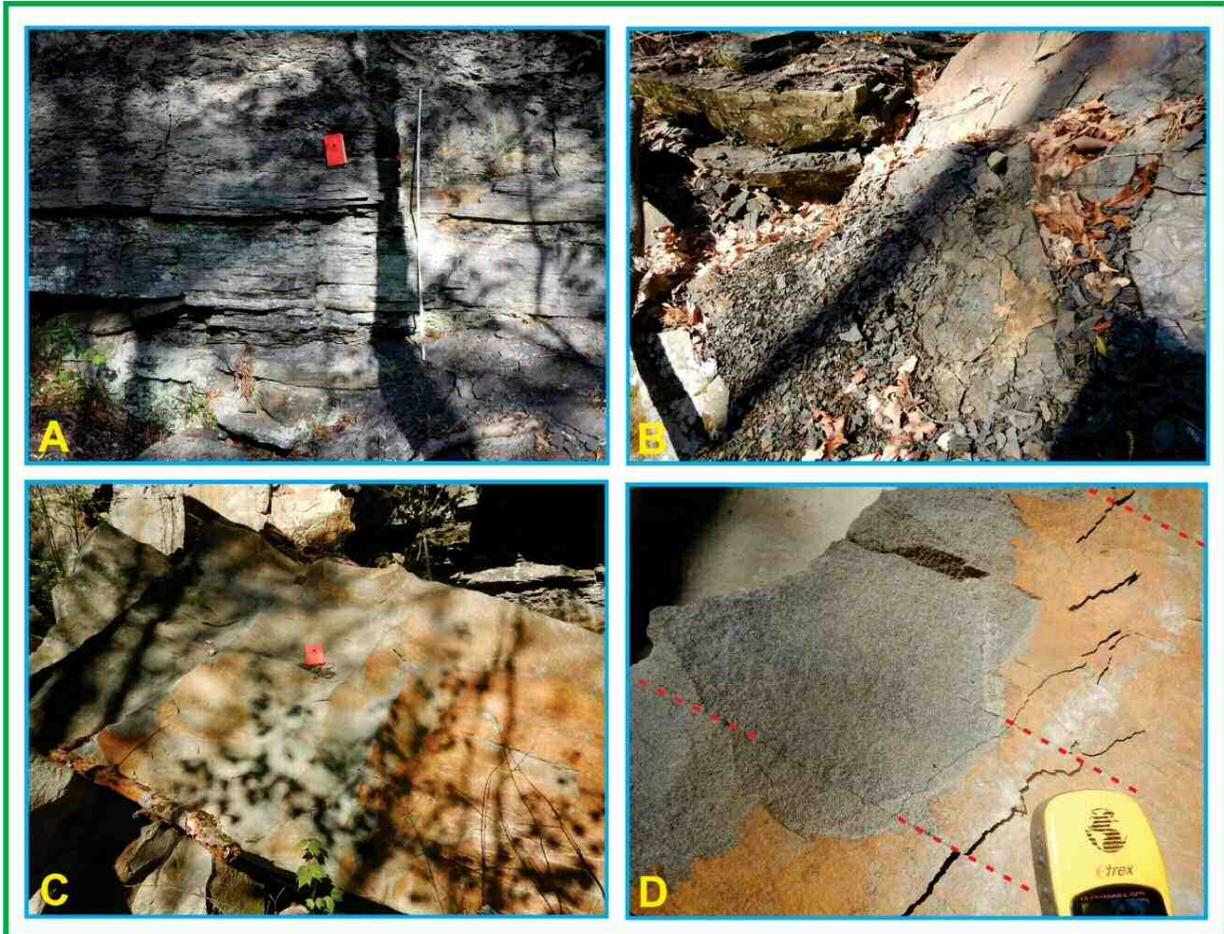
Hemlock Quarry interbedded shale and sandstone beds (A), weak, friable, shale (B), and massive fine-grained sandstone caprock with thin bedding plane partings (C & D).

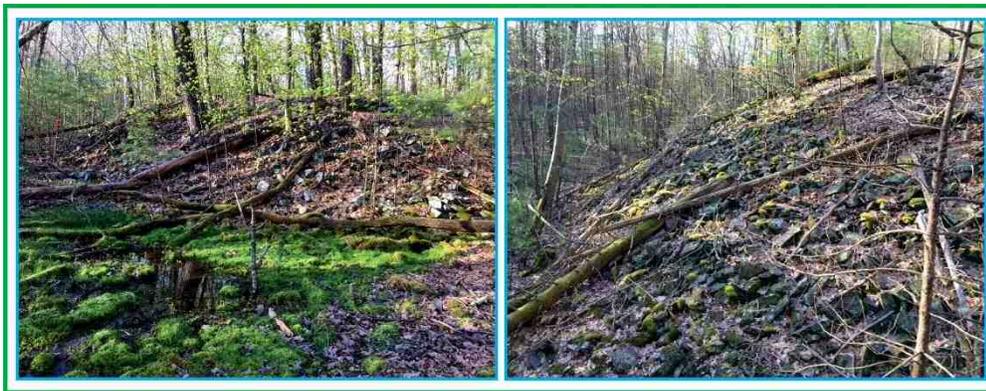
Pileated Spring issues from the base of a steeply sloping relict quarry rubble pile (green area) immediately north-northeast of Hemlock Quarry (see Fig. 1 location).

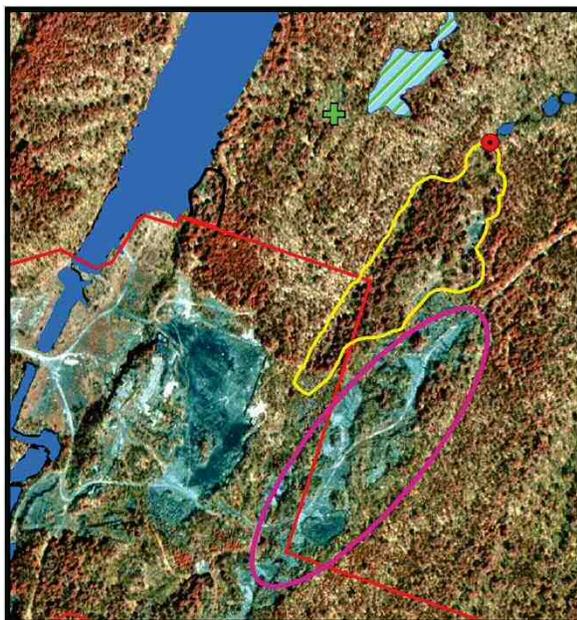
Alf Evers (1972) provides insight into the means by which the quarrying process used horse drawn derricks to leverage and swing blocks cut from quarry faces to the top of rubble piles where stonecutters shaped and sent them away for use. Drill and nail holes present in rubble blocks provide evidence of quarrying processes that date back some 200 years. This wooden derrick arrangement was probably used at the Hemlock Quarry, with derricks positioned atop the massive rubble piles located southeast of the working cliff face labeled on Figure 1. It is important to discern the difference between massive 1800's quarry rubble piles hidden amidst trees such as those outlined in yellow in the 1994 to 1998 digitally enhanced orthoimagery to the left provided from the New York State Department of State and relatively recent rock piles situated further to the

southeast (purple oval area) that were pushed together using modern heavy excavation machinery.

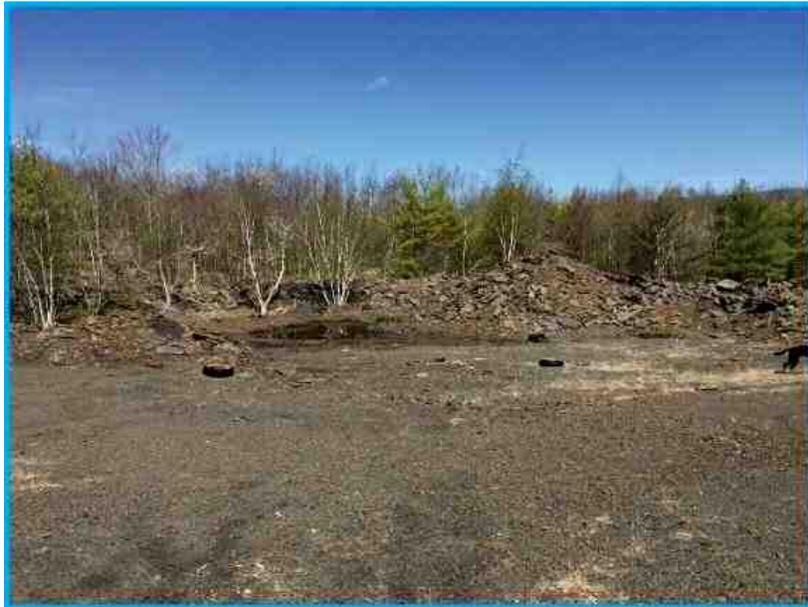
The photograph below shows the scraped bedrock floor and mounds of quarry debris pushed together by modern day heavy equipment - a very different physical appearance than that of historic quarry rubble piles.

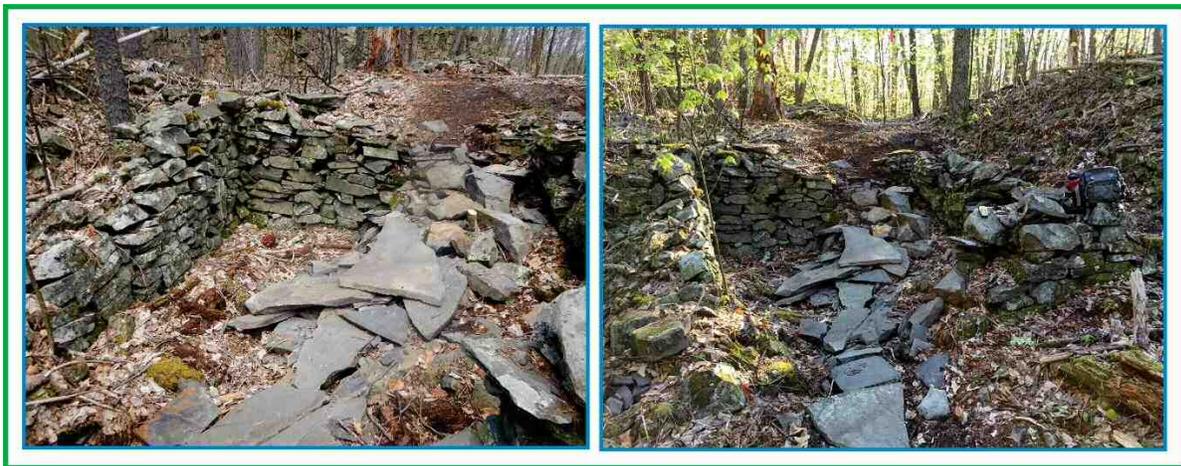
At least two foundations, each with evidence of an adjacent historic wagon pathway, are present near the northern end of the Hemlock Quarry footprint. One, pictured immediately below, measures 12 feet by 12 feet, has a wall thickness of 2 feet and maximum remaining foundation height of 4.5 feet. It appears to have been intentionally built into a quarry rubble mound. A second nearby foundation has wall remnants measuring 28 feet long by 4 feet high with a 2-foot wall thickness. Additional investigation is needed to determine the length of another degraded wall that may be 30 feet long. A low laid stonewall between foundations appears to reflect a former wagon pathway used to dump quarry rubble northward down a rubble embankment (right photograph above on page 6). Archaeological investigation in this area may lend greater interpretive significance to the larger composite cultural quarry feature.

Twelve-foot by twelve-foot foundation wall of what may be a former quarry building. Perhaps this building was used for secure storage of explosives and equipment.

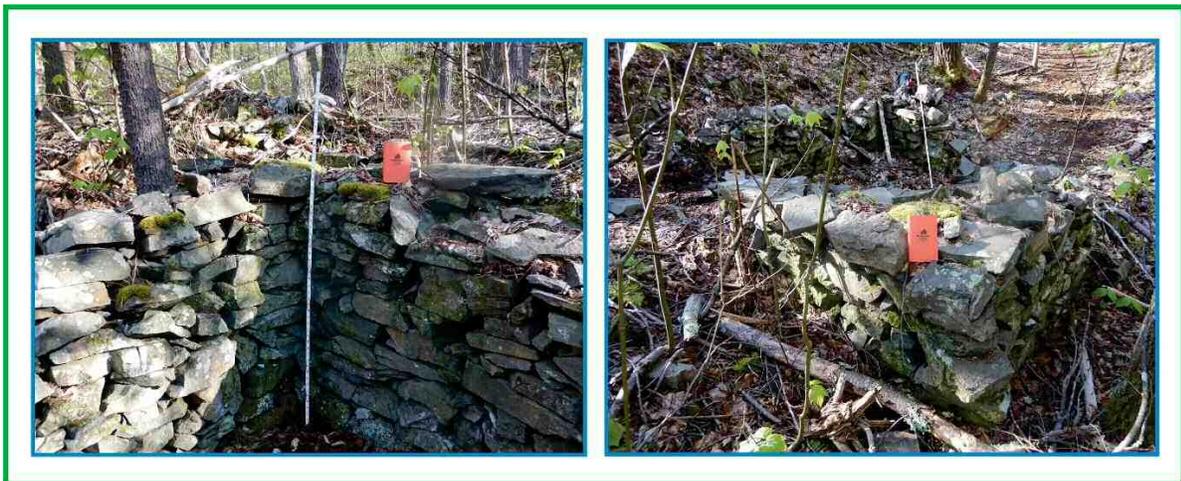
Inside and outside corners of the twelve-foot by twelve-foot foundation.

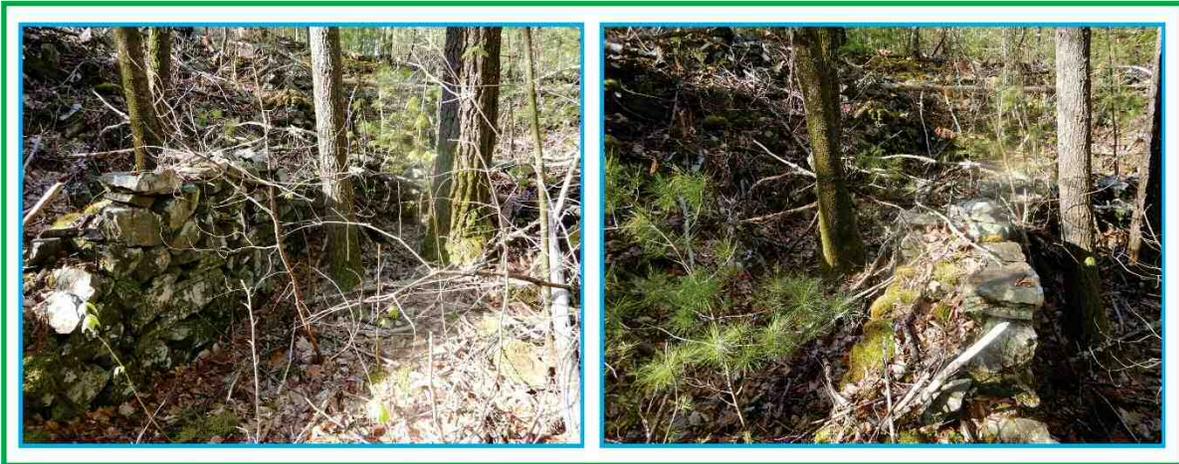
Second nearby and larger foundation remnant. Perhaps this was once a quarry headquarters building.

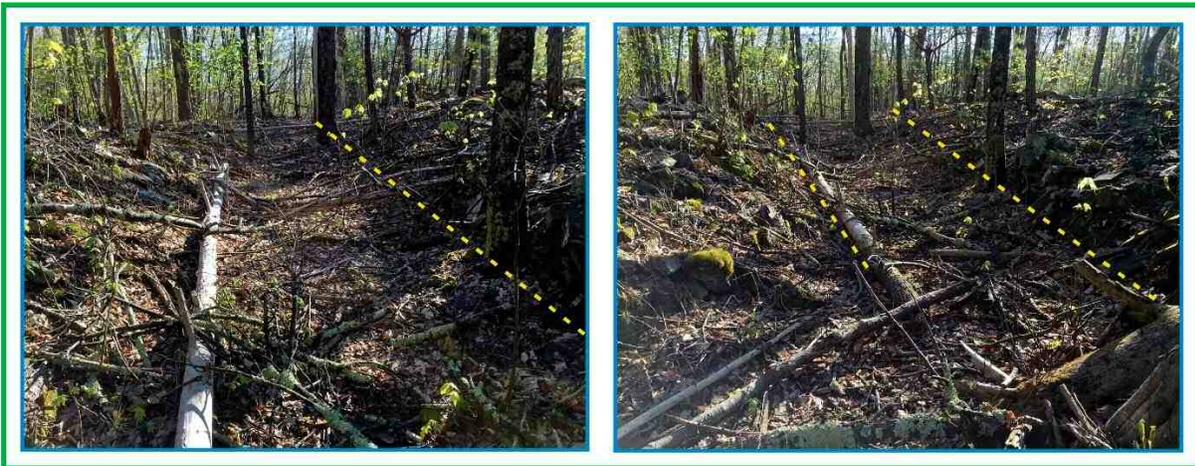
Yellow dashed lines define the boundary of a former wagon pathway between foundations.

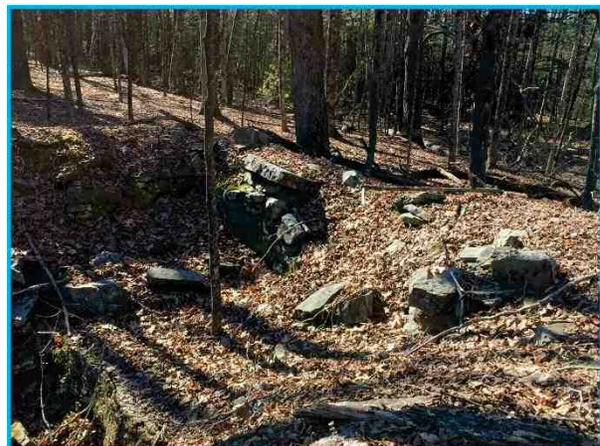
laid stone walls placed to keep quarry rubble from falling onto the road. At one location along this wagon road there is an old foundation (pictured above) that may have been a small home or an office (lower green + on the map below). A small dot on the 1875 Beers map depicts a building at this location and the name T. Beekman. The foundation is situated approximately 500 feet northwest of Hemlock Quarry, some 2,200 feet south of a quarry plotted on the 1875 Beers map, and directly along the old wagon road (see foundation photograph above on page 9). Historic research may reveal that Beekman was a quarry owner or foreman who oversaw operations in multiple nearby quarries.

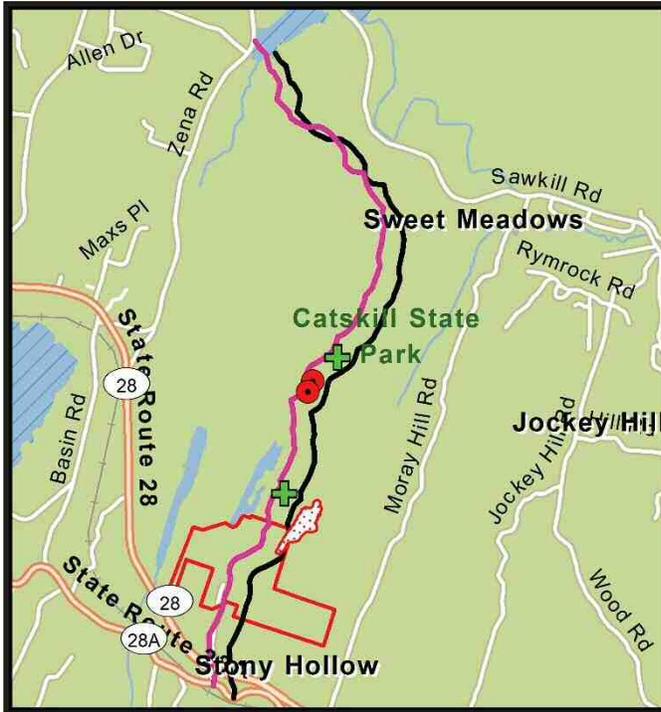
Map 1. Reconstructed Route of Waghkonk Trail and Wagon Road.

A portion of this old wagon road was removed by modern quarrying operations on the 850 Route 28 LLC site sometime after 1972. This roadway no longer appears on modern maps, but does appear on the 1875 Beers map. Because determination of the location of the old wagon road is essential in reconstructing a comprehensive picture of the full bluestone industry in Bluestone Wild Forest, an effort was made to reasonably determine the road's pathway. To this end, ESRI software was used to georeference portions of the Beers map and align it spatially. This was accomplished using carefully selected tie in points to correlate the position of the old wagon road with modern fixed features, primarily the intersections of a railway bed and the Saw Kill with extant roads. Once

the old wagon road was spatially oriented, it was overlain with other known features including the 850 Route 28 site boundary, roads, and waterways. The black roadway line on the map above depicts the result of the georeferencing effort. Considering the extensive change in area road alignments over the last 145 years, this alignment is reasonably correct. However, it does not exactly match the current position of Waghkonk Road that may represent the original route of the Waghkonk Trail. The purple line on the above map represents a slightly shifted alignment of the original georeferenced black roadway position, moved 400 to 500 feet westward to match the trend of Waghkonk Road. The wagon road lies within, or very close to, the two bounding lines presented on the map above. This is, in part, confirmed by two locations within Bluestone Wild Forest where the old roadway is obvious. These two locations are depicted as green plus signs on the map above. The wagon road at the upper plus sign is positioned between hillslopes to either side. The lower wagon road location depicted by a plus sign on the map above is a short distance east of an old building shown on the 1875 Beers map associated with the name T. Beekman.

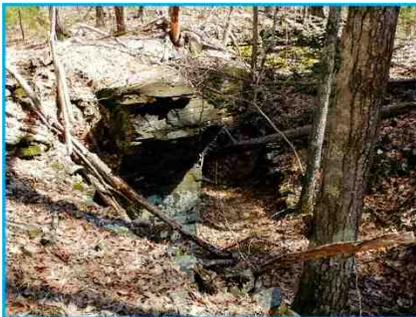
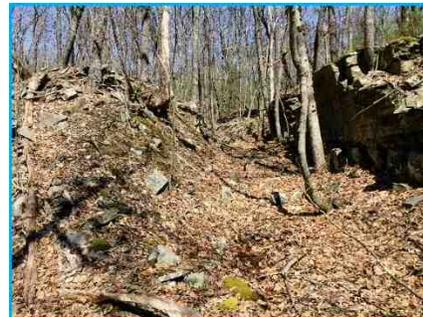
2,750 feet north of Hemlock Quarry (two red dots on page 10 map above). Two photographs above show the much smaller nature of this quarry area versus that of Hemlock Quarry.

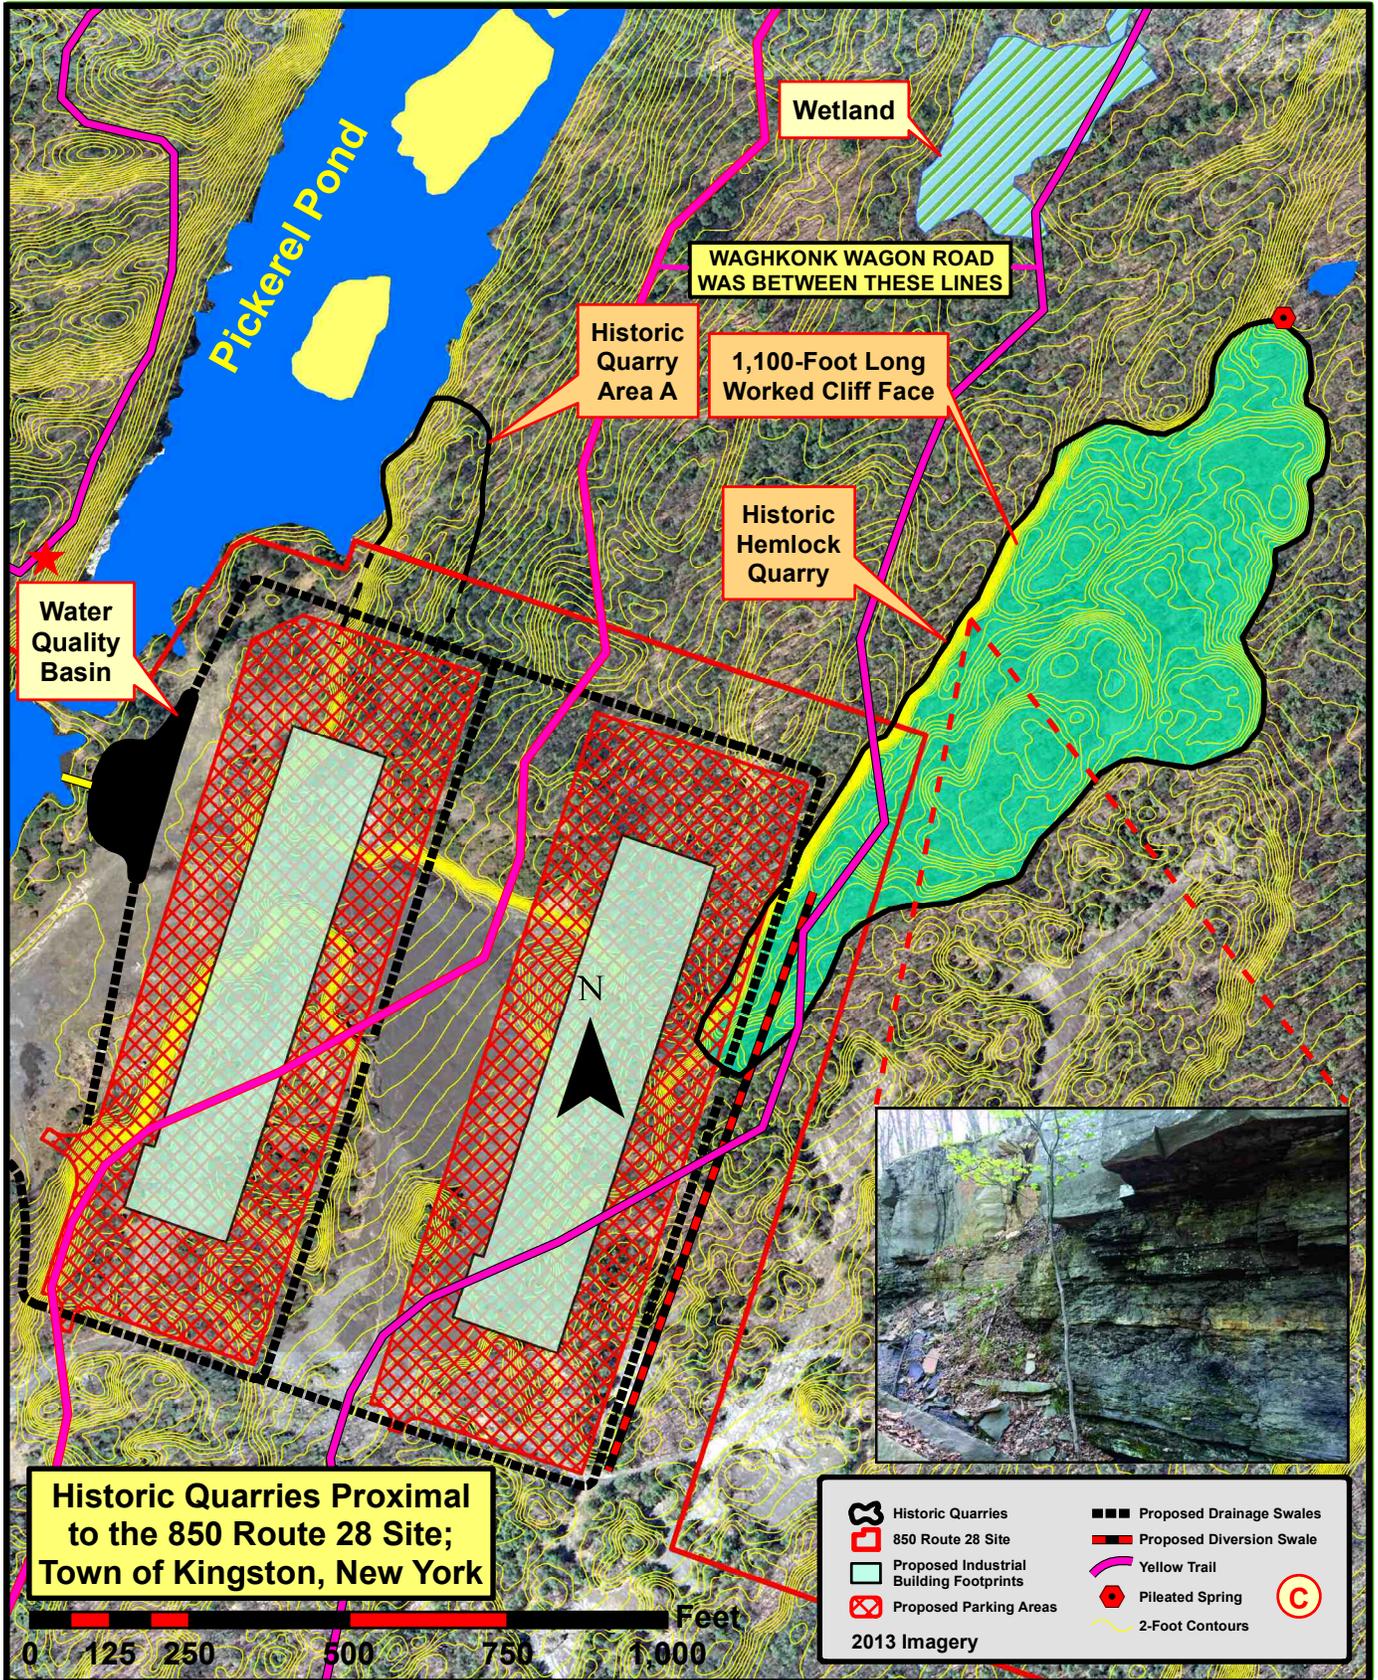
Figure 1 Map Date: 5-26-20

Figure 1 shows the location of Hemlock Quarry, a premier historic quarry. Portions of this quarry are present on New York State preserved lands and portions of it are in private ownership (approximately 600 feet). The physical extent of the quarry is discerned here based on field reconnaissance on preserved lands, detailed assessment of LiDAR-derived 2-foot elevational contours, review of a number of years of high resolution orthoimagery, and geologic assessment. Field evaluation of that portion of the quarry on private land is recommended. The undisturbed nature of this quarry and working area provide an outstanding opportunity for geologists and cultural archaeologists to study and interpret historic quarrying methods and the historic quarry's functioning infrastructure. In essence, Hemlock Quarry reflects a time capsule of pre-Civil War industrial quarrying methods.

The areal extent of the quarried Hemlock Quarry cliff face is well-approximated on 2013 imagery and on a 2-foot elevational map (Figure 1). Together, they show a linear north-northeast to south-southwest oriented vertical cliff face extending continuously for a distance of approximately 1,100 feet. Photographs on page 2 above show a portion of this worked cliff face. The height of exposed bedrock below the massive sandstone caprock shows that quarry workers sought both the upper massive sandstone layers and lower thin sandstone beds where they were present. Removal of the weak shale beds at the base of the quarried cliff provided a staging area where the overlying bluestone caprock could be either dropped or swung after blasting. This provided a means to safely exploit the bluestone along bedding plane partings and vertical fractures.

While additional fieldwork is warranted to verify the physical boundary, working areas, and attributes of quarry rubble associated with the Hemlock Quarry, assessment of elevational contour data and initial field reconnaissance allowed the reasonable 9-acre approximation depicted on Figure 1. See, for example, the sharp change in gradient proximal to Pileated Spring that issues from the base of an arcuate and steeply sloped sandstone rubble pile (see photographs on top of page 6).

Construction of the 850 Route 28 manufacturing facility would irreparably compromise the integrity of Hemlock Quarry. Project plans show that blasting and site grading would occur through the southwestern end of Hemlock Quarry for construction of a large parking area and diversion and drainage swales (Figure 1). Detailed cultural resource investigation and preservation is warranted.
