## Channelization of Humbolt and Upper Flat Rivers: Lateral and Vertical Hydraulic Constraints

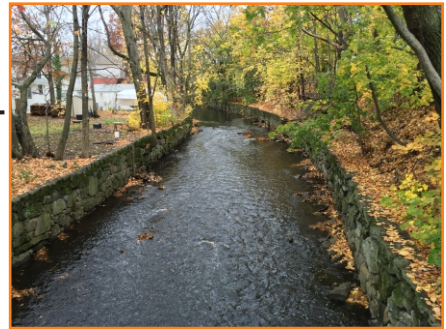
2007 overbank floodwater height  
~ 6.3 ft above 1936 laid stone wall

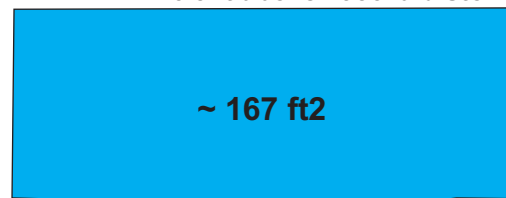
Channel cross-section beneath  
Cascade Park foot bridge deck

Significant portions of both the Upper Flat and Humbolt rivers have been extensively channelized coincident with building and bridge construction. This has reduced the areal extent of the natural floodplain and increased river velocity. Riprap and cement walls now laterally constrain river flow until floodwater flows overbank into adjacent areas. Low bridges have served to both laterally and vertically constrain channel cross-sectional areas. The hydraulic response to this is back flooding upriver of low bridges, inclusive of the Verdent and Silver avenue bridges. Calibration against flood levels depicted in 2011 and 2007 photographs reveal the damming effect of such bridges (e.g., Verdent Ave. above). Flood levels artificially elevated behind bridge dams compound upriver flooding impacts above normal flood levels. Flood level reduction requires increasing channel cross-sectional areas, especially under bridges, to accommodate flood flows. HydroQuest graphic.

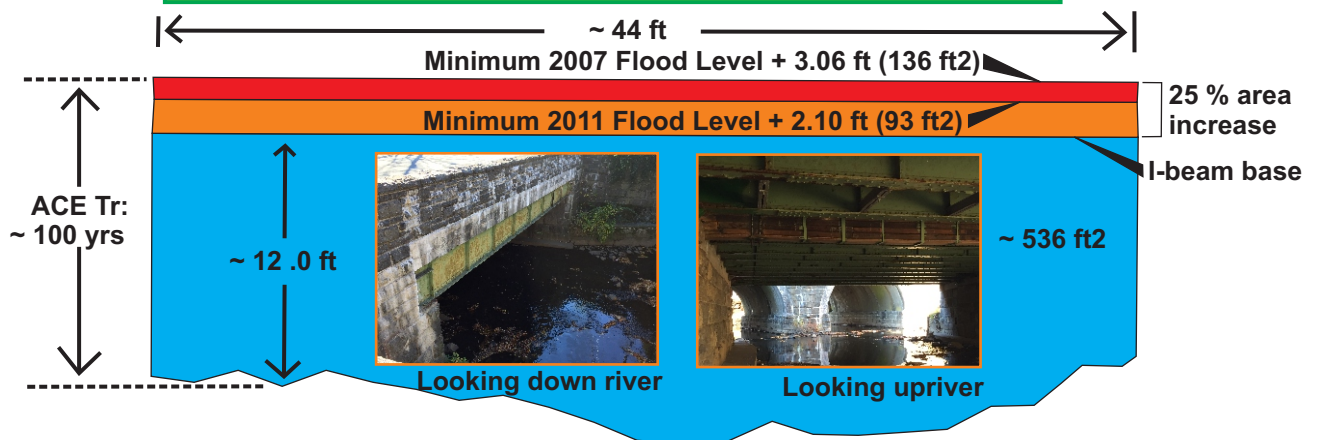
Channel cross-section beneath the Verdent Ave bridge
